June 14, 2018 Accident
Failure Investigation Report
Sand Blaster Roller Coaster
Boardwalk Amusements, Daytona Beach, Florida

Prepared for the Florida Department of Agriculture and Consumer
Services, Bureau of Fair Ride Inspections

Failure Analysis Investigation Report
June 14, 2018 Accident
Sand Blaster Roller Coaster
Boardwalk Amusements Daytona Beach, Florida
Florida Department of Agriculture and Consumer Services, Bureau of Fair Ride Inspections

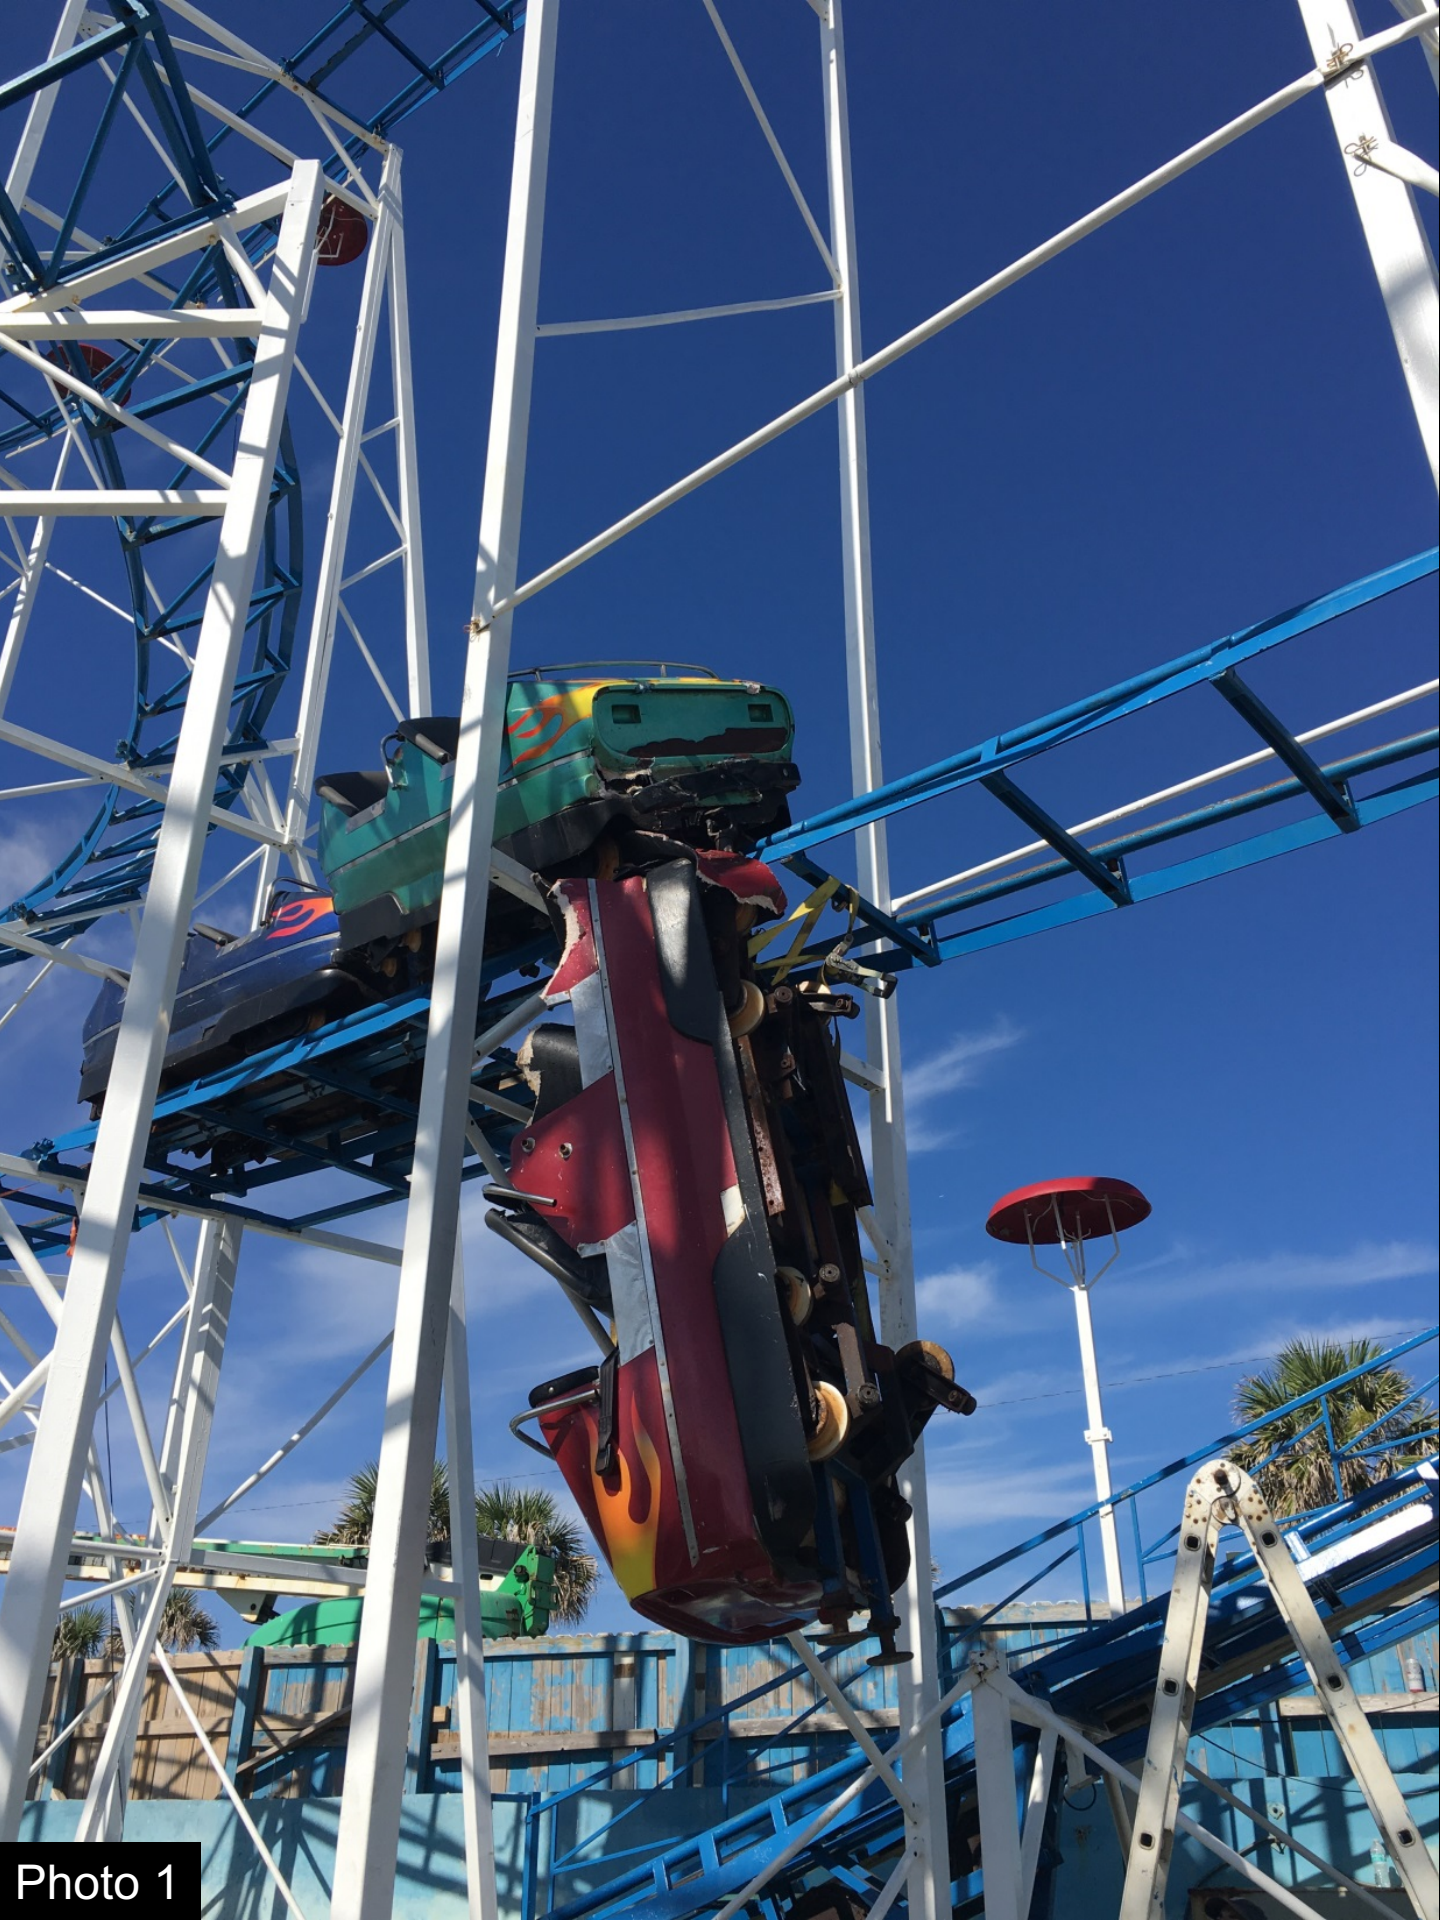
Photo 1

Reportedly the ride was initially erected in the Northeast in the early 70's, and was refurbished and erected in Daytona Beach in 2013. The ride was built by Pinfari and is classified as a 64m model, and has a single three car train. The ride is 51 feet tall at its peak and the accident occurred at an elevation of 17 feet. Each car is about 7 feet long. After the accident, two cars remained on the track and one was suspended about 10 feet off the ground. See Photos 1-3.

- The lead car exited the track and struck a vertical support with its right side. (Photo 17)
- The collision forces partially derailed the one of the following cars which remained on the track. (Photo 1)

- The lead car became suspended vertically, hanging from the second car. (Photo 1)

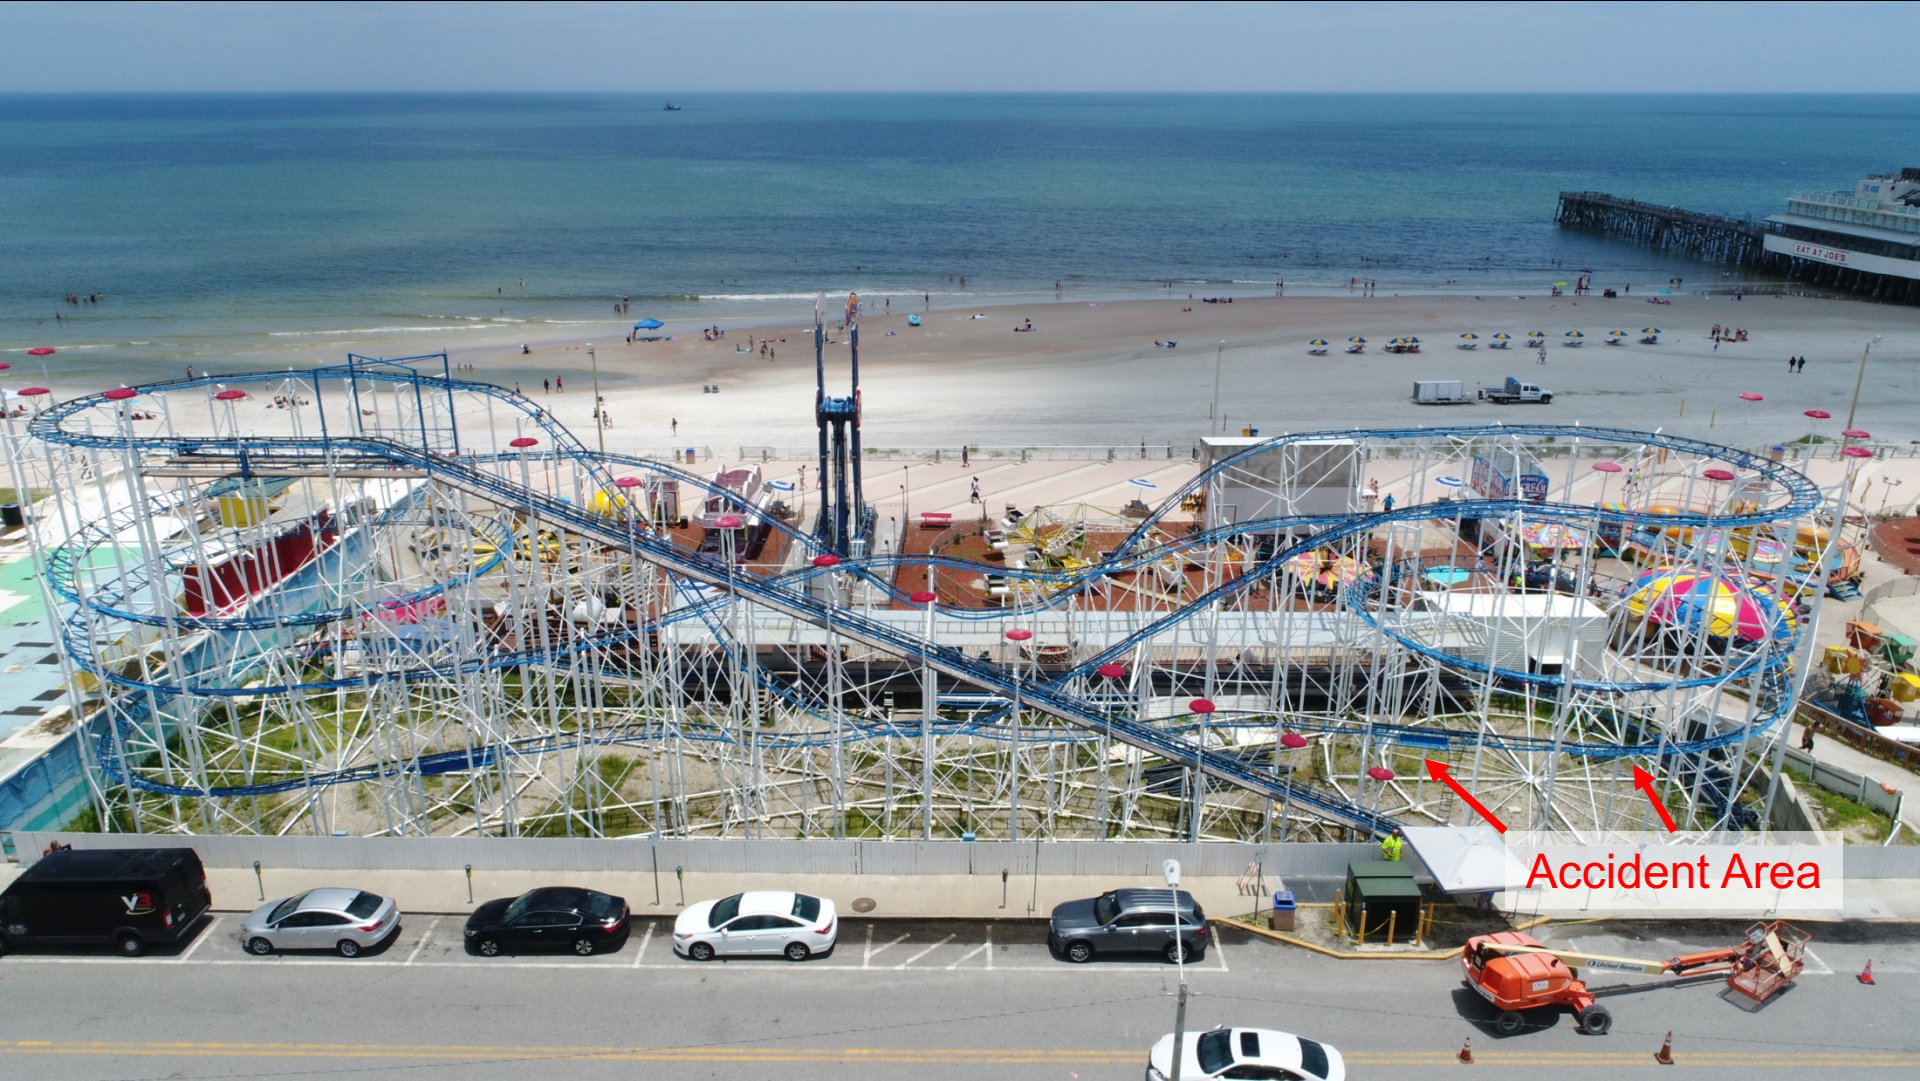
- The 3 car group was exiting a 540 degree spiral curve near the bottom of the ride. (Photo 2)
- The right side nylon wheels began lifting off of the track due to high speed and centrifugal cornering forces.

Accident Area

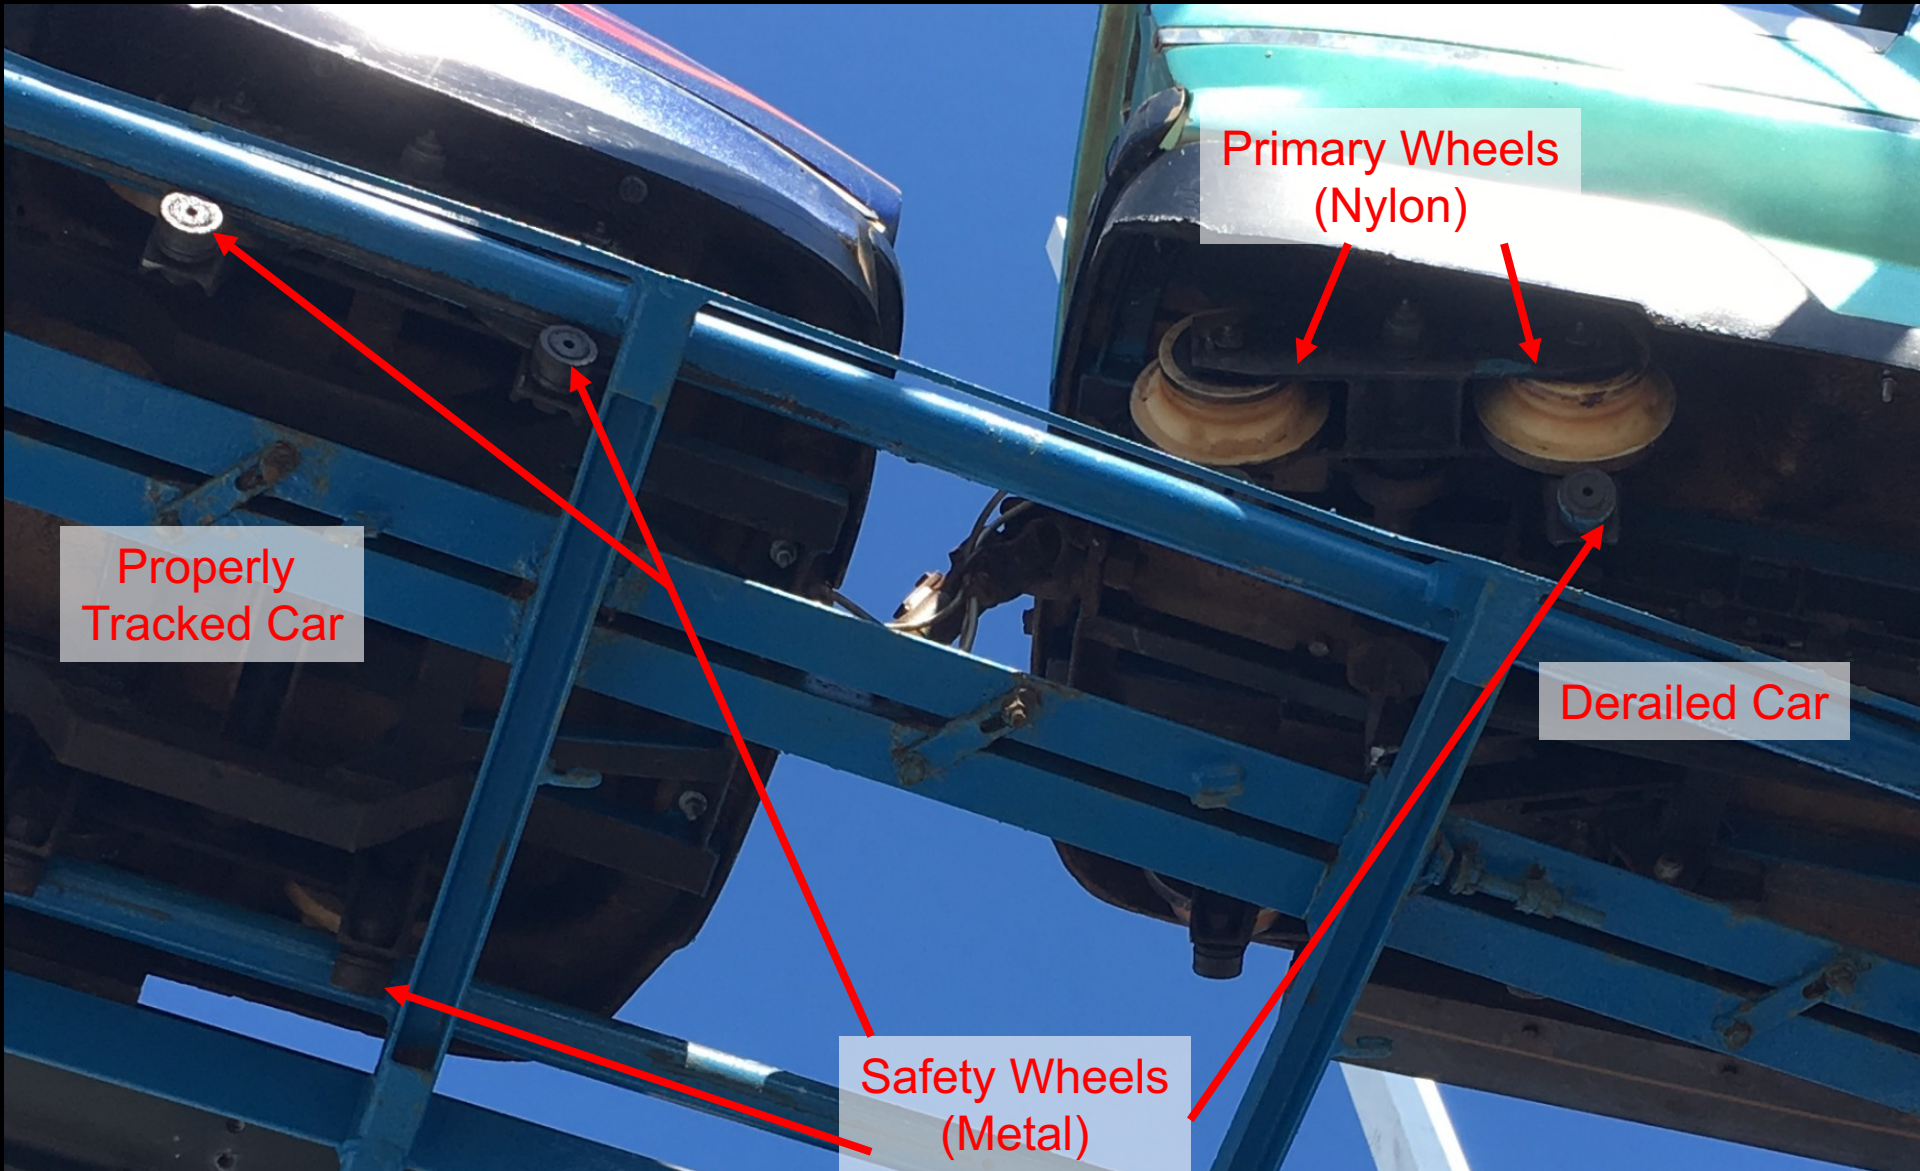
Photo 5

The Subject rollercoaster is a simple car on wheels design that follows a metal track similar to a locomotive on a train track. The ride is a gravity ride, meaning that the cars are rolling from a location of higher elevation to a lower elevation to generate speed. Simply put, the cars are rolling downhill on specifically shaped wheels to follow along a metal track made of two inch diameter steel pipe. The ride is not intended to perform negative G's, inverted activities or extreme maneuvers. In the event that a car does attempt to lift off the track, the car has "safety wheels" that extend underneath the track to prevent the car from derailing. Photos 4 and 5 show a derailed car and a properly tracked car. The metal safety wheel is visible beneath the track on the left most car and the tan colored nylon primary wheel is visible in the derailed condition on the right most car. See Drawing 3.

Properly Tracked Car

Primary Wheels (Nylon)

Derailed Car

Safety Wheels (Metal)

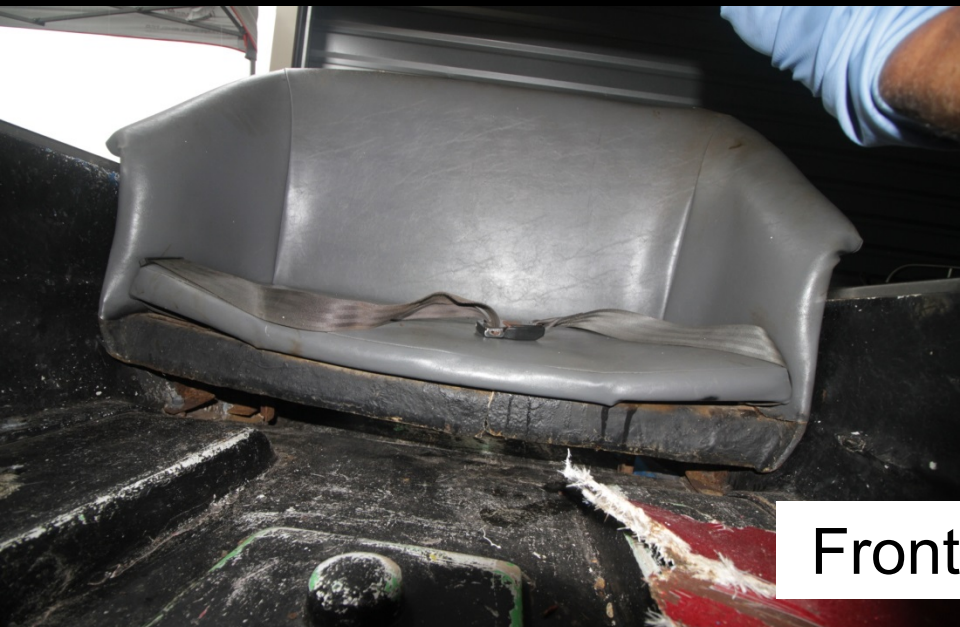
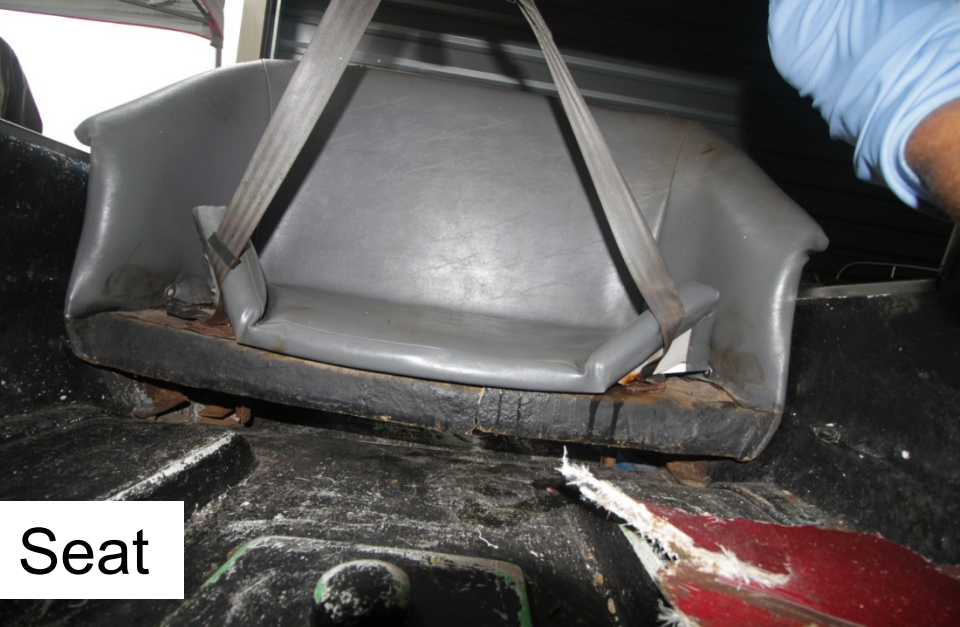
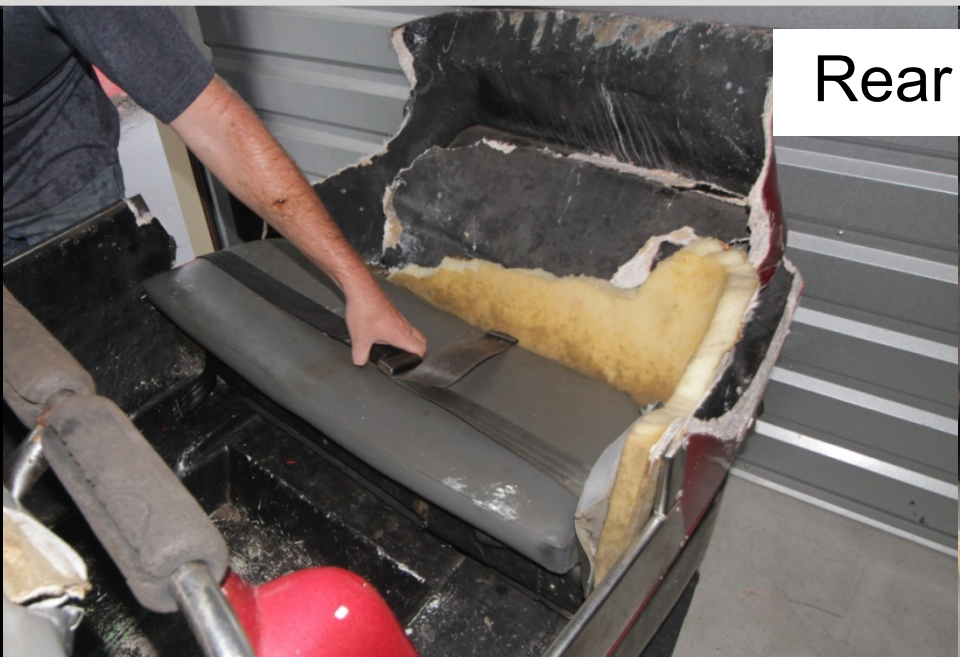
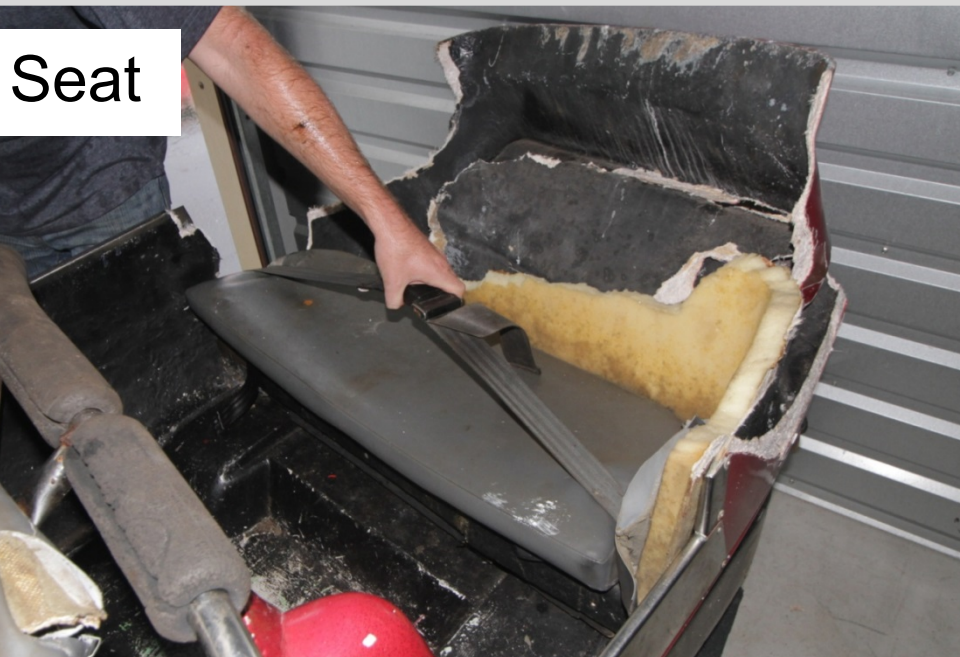
Seatbelts were added to the cars in the 2013 refurbishment; however, one belt was used for both occupants in a seat and the attachment point of the belt was poorly placed allowing for excess slack of the belt in an accident. See Photo 6.

Front Seat

Rear Seat

Photo 6: Composite Lead Car Seat Belts

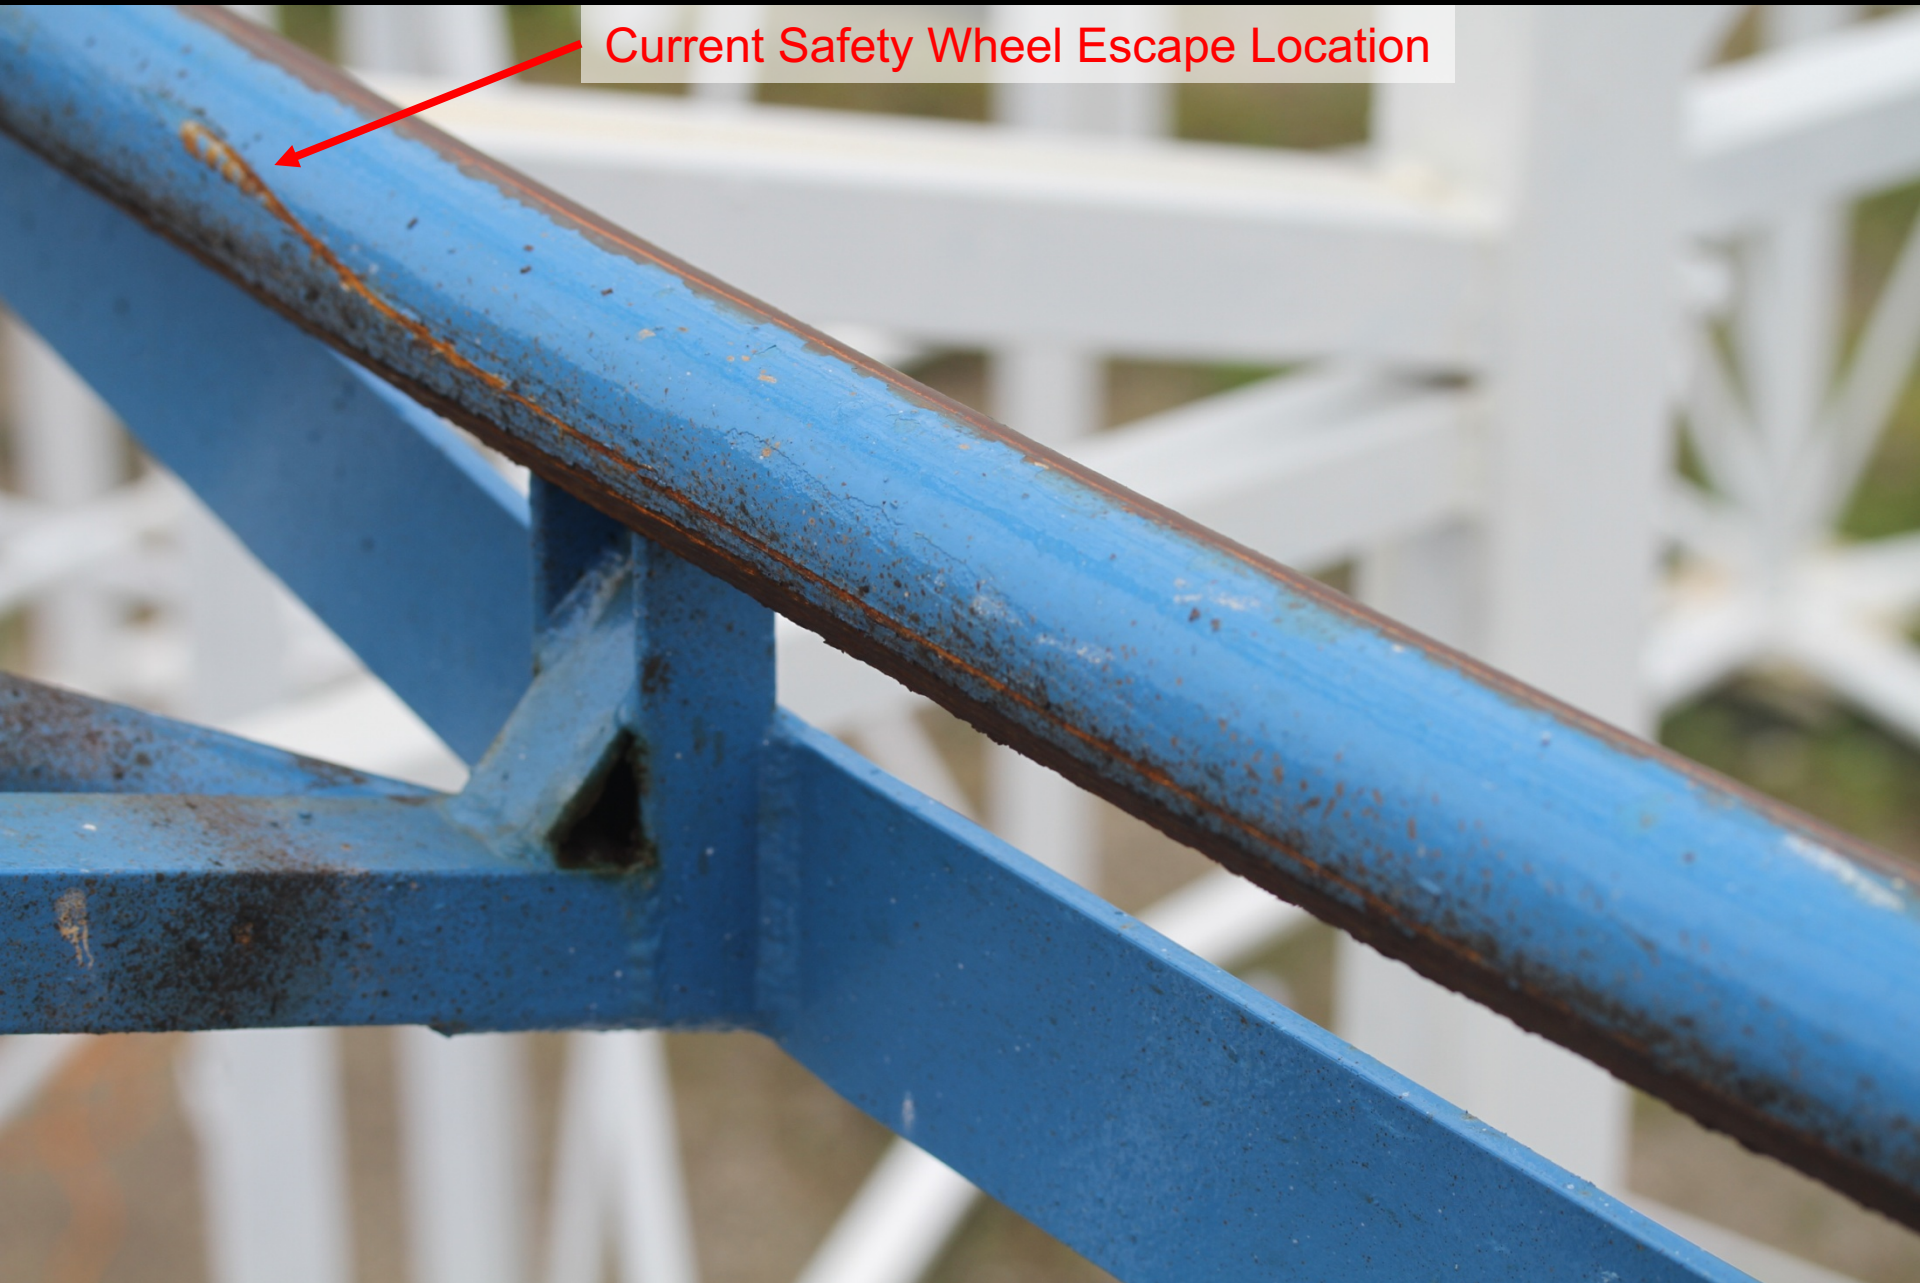
Under close inspection of the track, two fresh and distinctive gouge marks near the underside of the right hand track rail were found. These marks started on the underside of the track, passed along the midline of the track and exited the top of the track. They were about 4 feet long and are identified in this report as safety wheel escape locations. The presence of these marks indicates a partial right side derailment by the lead car. They initiated from a worn strip on the underside of the track, which clearly indicated a long term wear pattern by the safety wheels contacting the track. See Photos 7 and 8 showing the first mark and the track wear. The primary wheels are made of nylon and will wear out over time. Our measurements indicate these nylon wheels are still within their acceptable service life. The safety wheels are made of steel and are not designed to regularly contact the track; they are a safety mechanism only and should only touch the track in the event that a car tries to escape the track.

Current Safety Wheel Escape Location

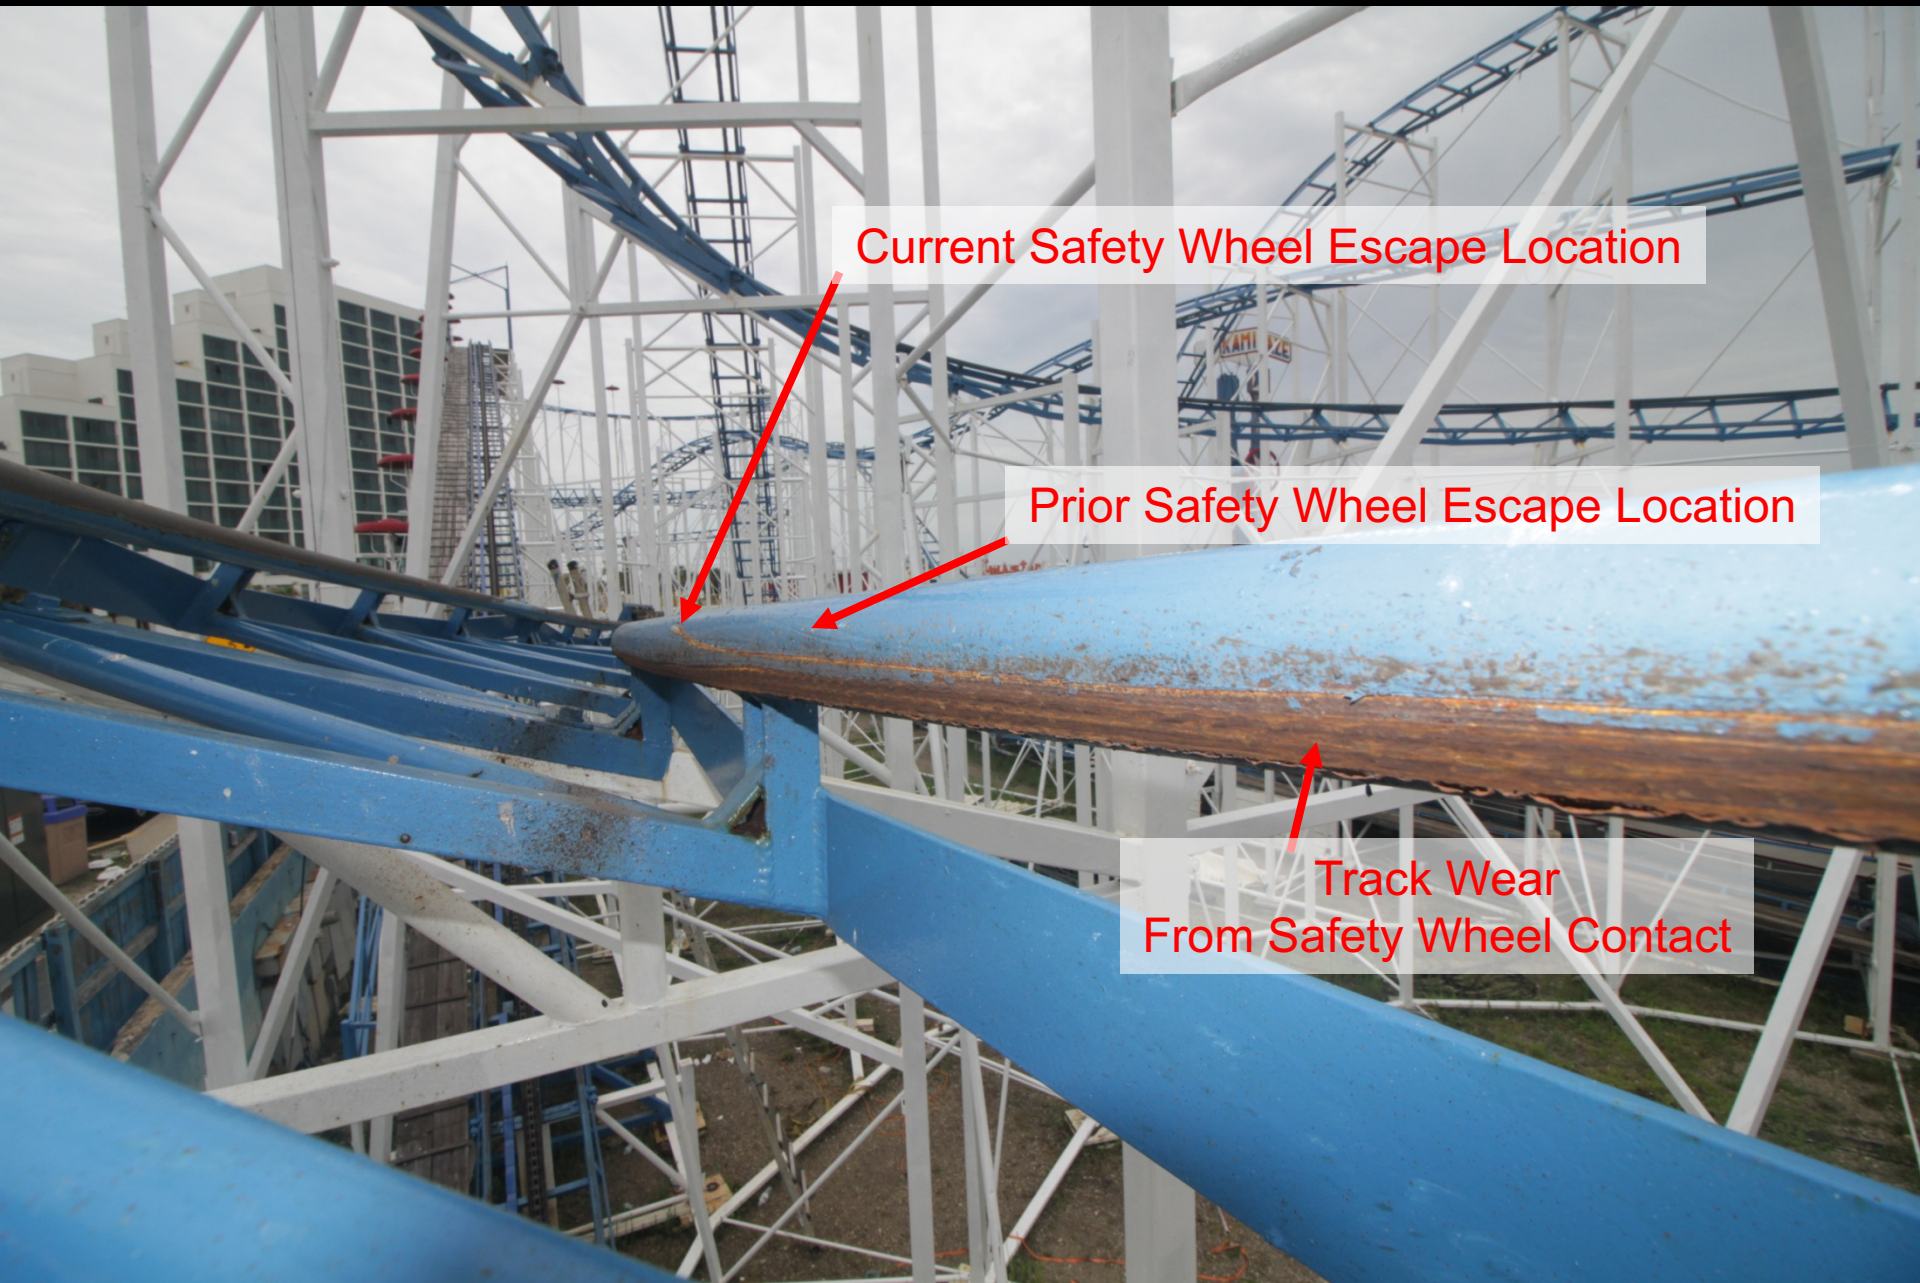
Current Safety Wheel Escape Location

Prior Safety Wheel Escape Location

Track Wear
From Safety Wheel Contact

Safety Wheel Gouges

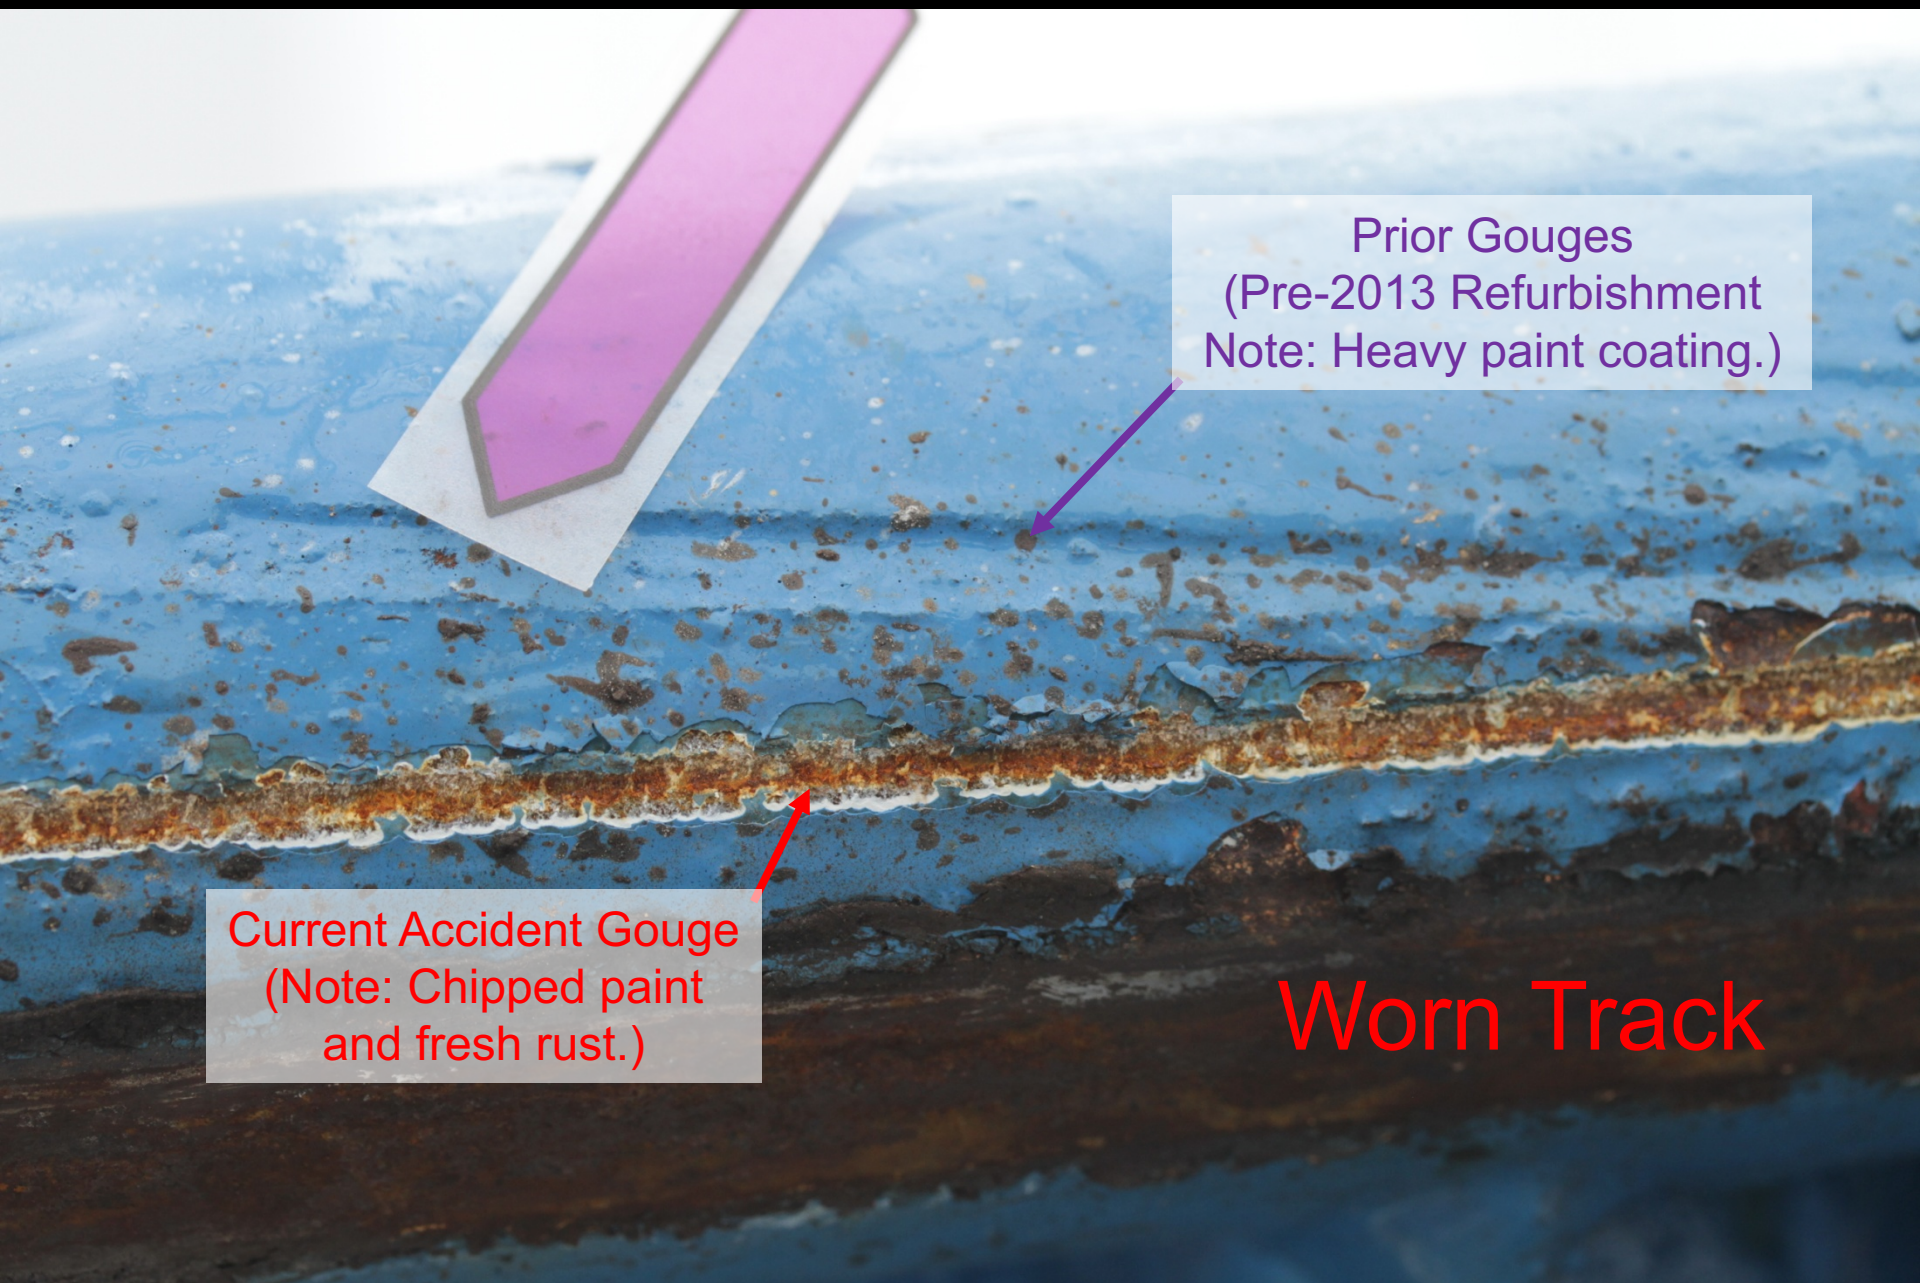
Additionally, evidence on the track at the location of the fresh gouge marks conclusively demonstrated repetitive and long-term evidence that the basic accident events had happened many times before (but presumably not with similarly injurious results). Photo 9 shows the fresh accident gouge (fresh colored rust) surrounded by freshly chipped paint along with an obvious groove representing a prior gouge that has been painted over. Photo 10 contains 6 purple flags marking obvious painted over grooves, with several unmarked grooves as well.

Prior Gouges
(Pre-2013 Refurbishment
Note: Heavy paint coating.)

Current Accident Gouge
(Note: Chipped paint
and fresh rust.)

Worn Track

Prior Gouges
(Pre-2013 Refurbishment)

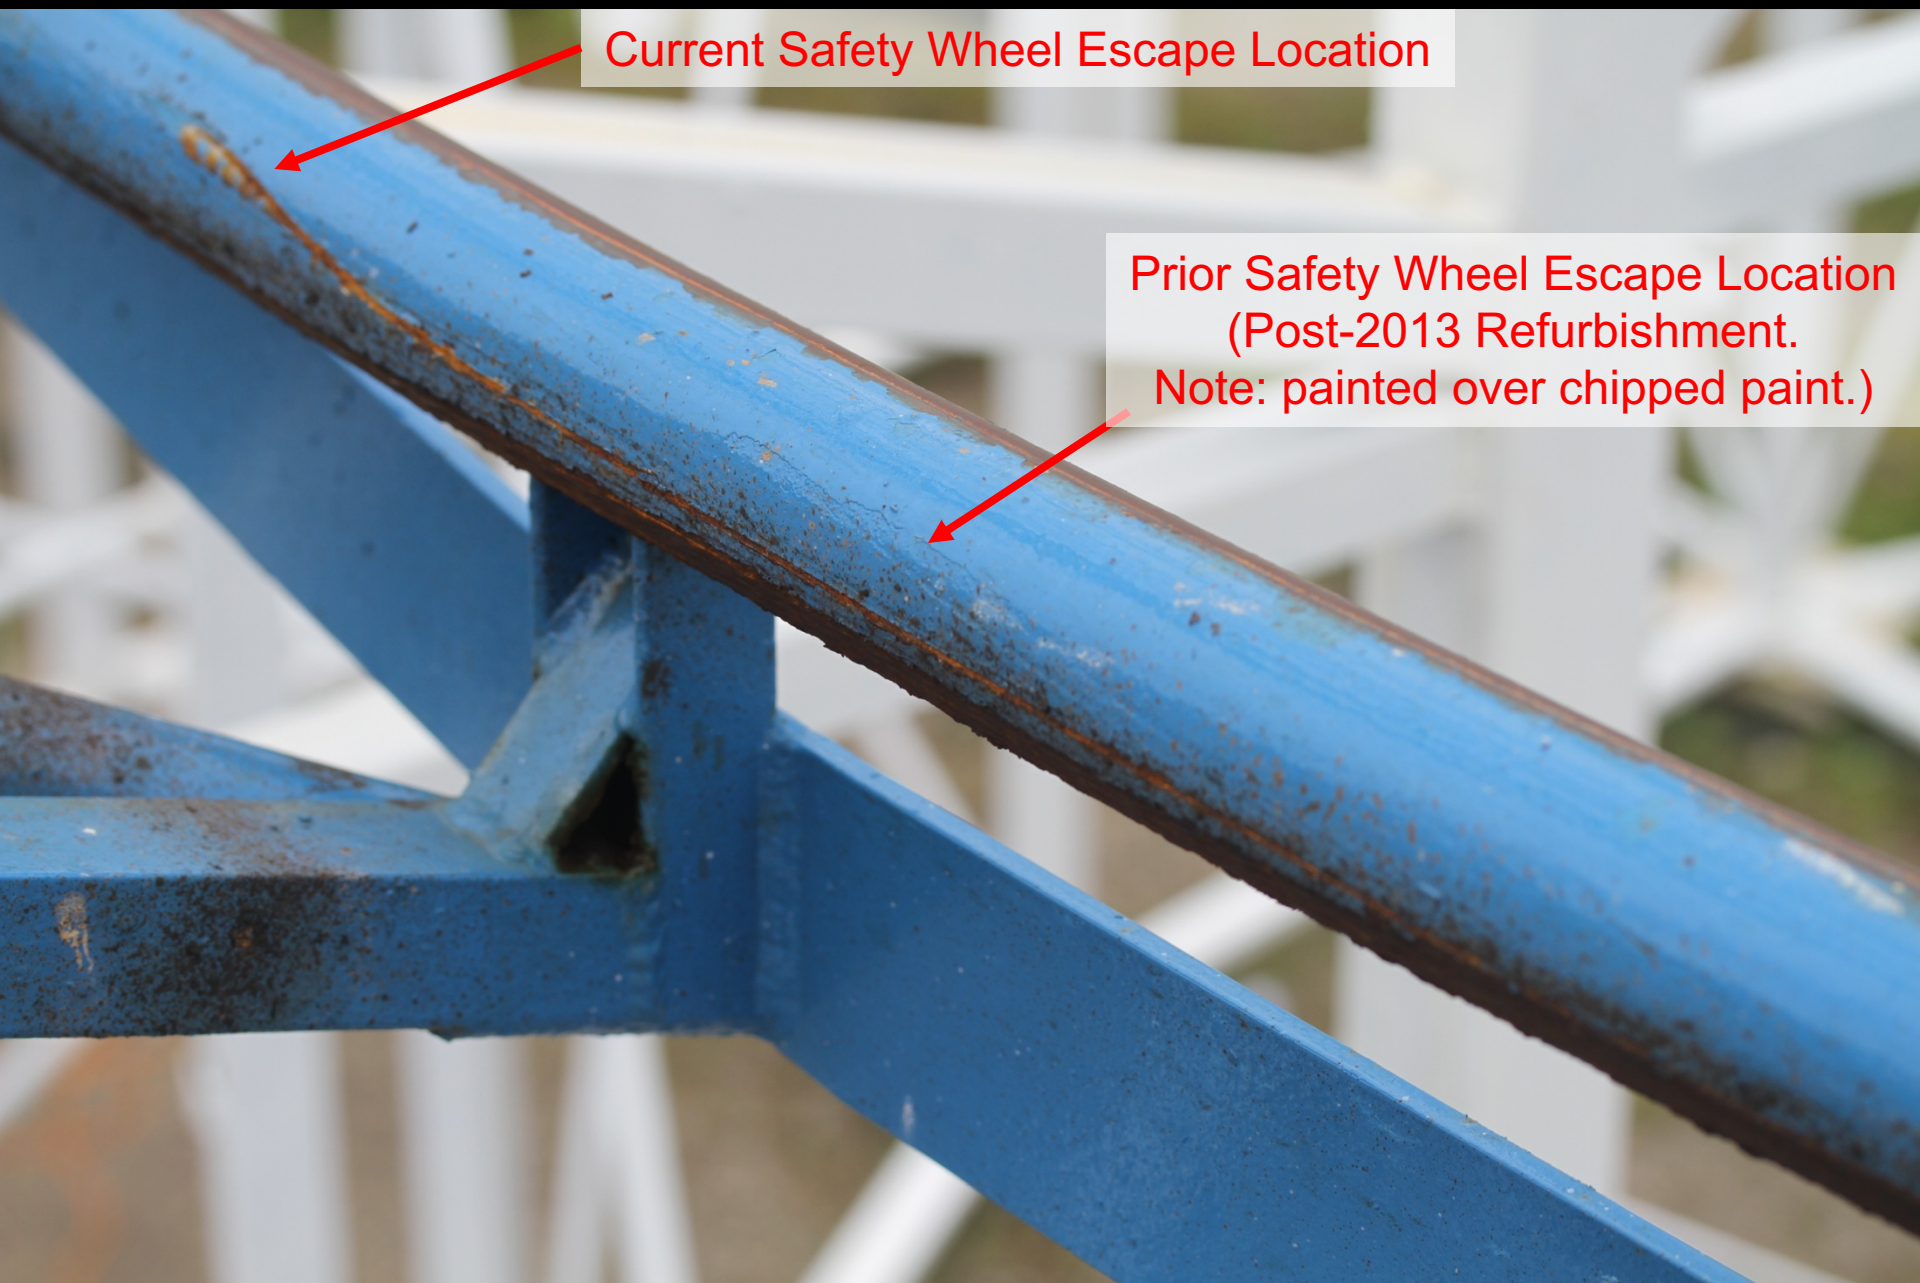
There is also evidence that in very recent history an accident very similar to the subject accident involving car derailment and brake structure impact has occurred. Photos 11 and 12 show a painted over groove with painted over chipped paint. Currently, the ride has a fresh coat of blue paint; however, Google imagery demonstrates that the ride was not repainted prior to June 2017. These facts indicate that sometime between the 2013 refurbishment and the date of the subject accident one car derailed and the evidence was painted over.

- The car's right side safety wheels located beneath the track began rolling along the bottom of the track, thus preventing car overturn. (Drawing 4)
- The edge of the lead car's safety wheels carved an upward gouge or groove in the track. (Photo 11)

Current Safety Wheel Escape Location

Prior Safety Wheel Escape Location
(Post-2013 Refurbishment.
Note: painted over chipped paint.)
