June 14, 2018 Accident
Failure Investigation Report
Sand Blaster Roller Coaster
Boardwalk Amusements, Daytona Beach, Florida

Prepared for the Florida Department of Agriculture and Consumer
Services, Bureau of Fair Ride Inspections

Failure Analysis Investigation Report
June 14, 2018 Accident
Sand Blaster Roller Coaster
Boardwalk Amusements Daytona Beach, Florida
Florida Department of Agriculture and Consumer Services, Bureau of Fair Ride Inspections

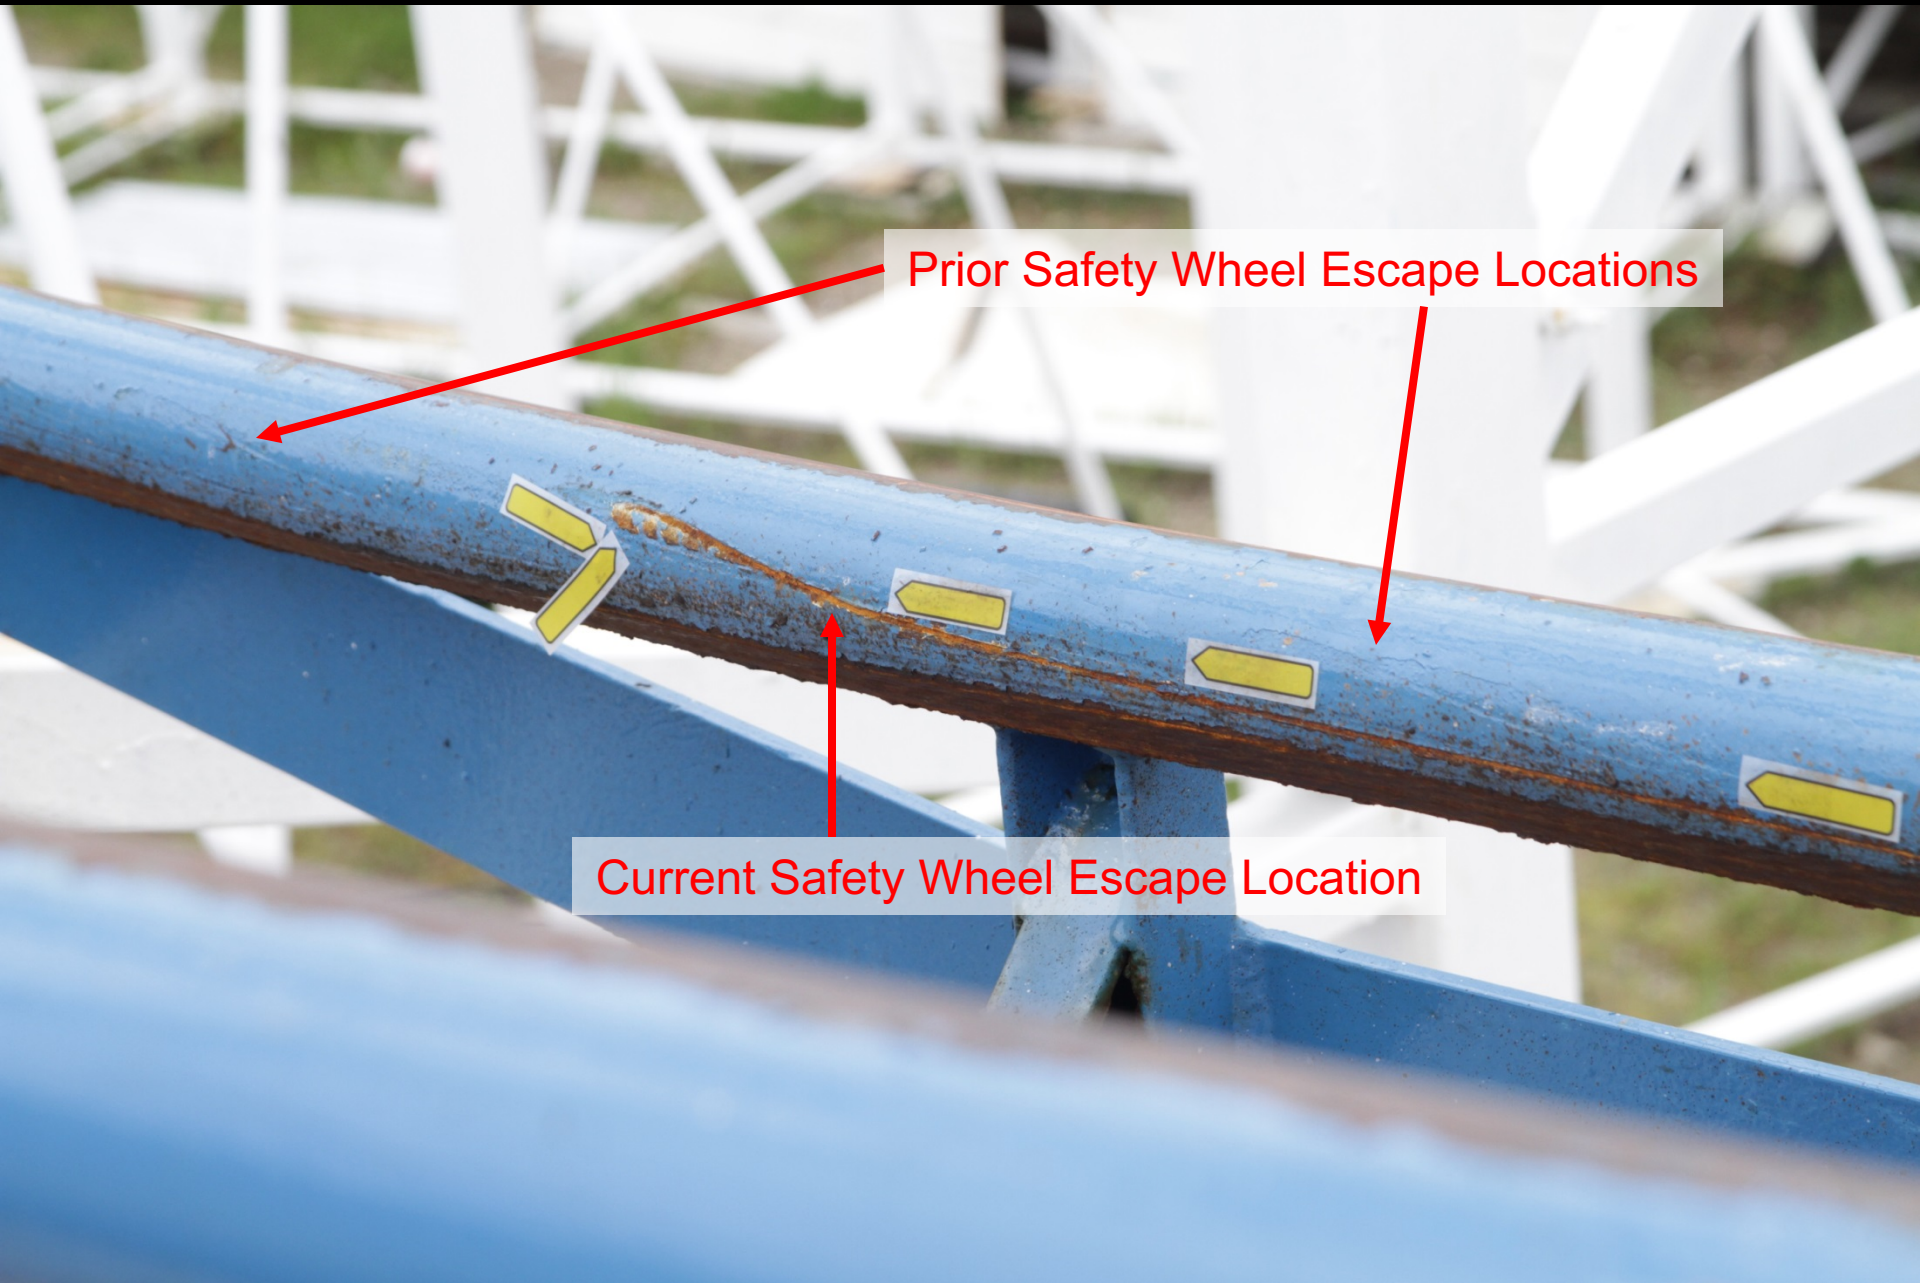
Prior Safety Wheel Escape Locations

Current Safety Wheel Escape Location

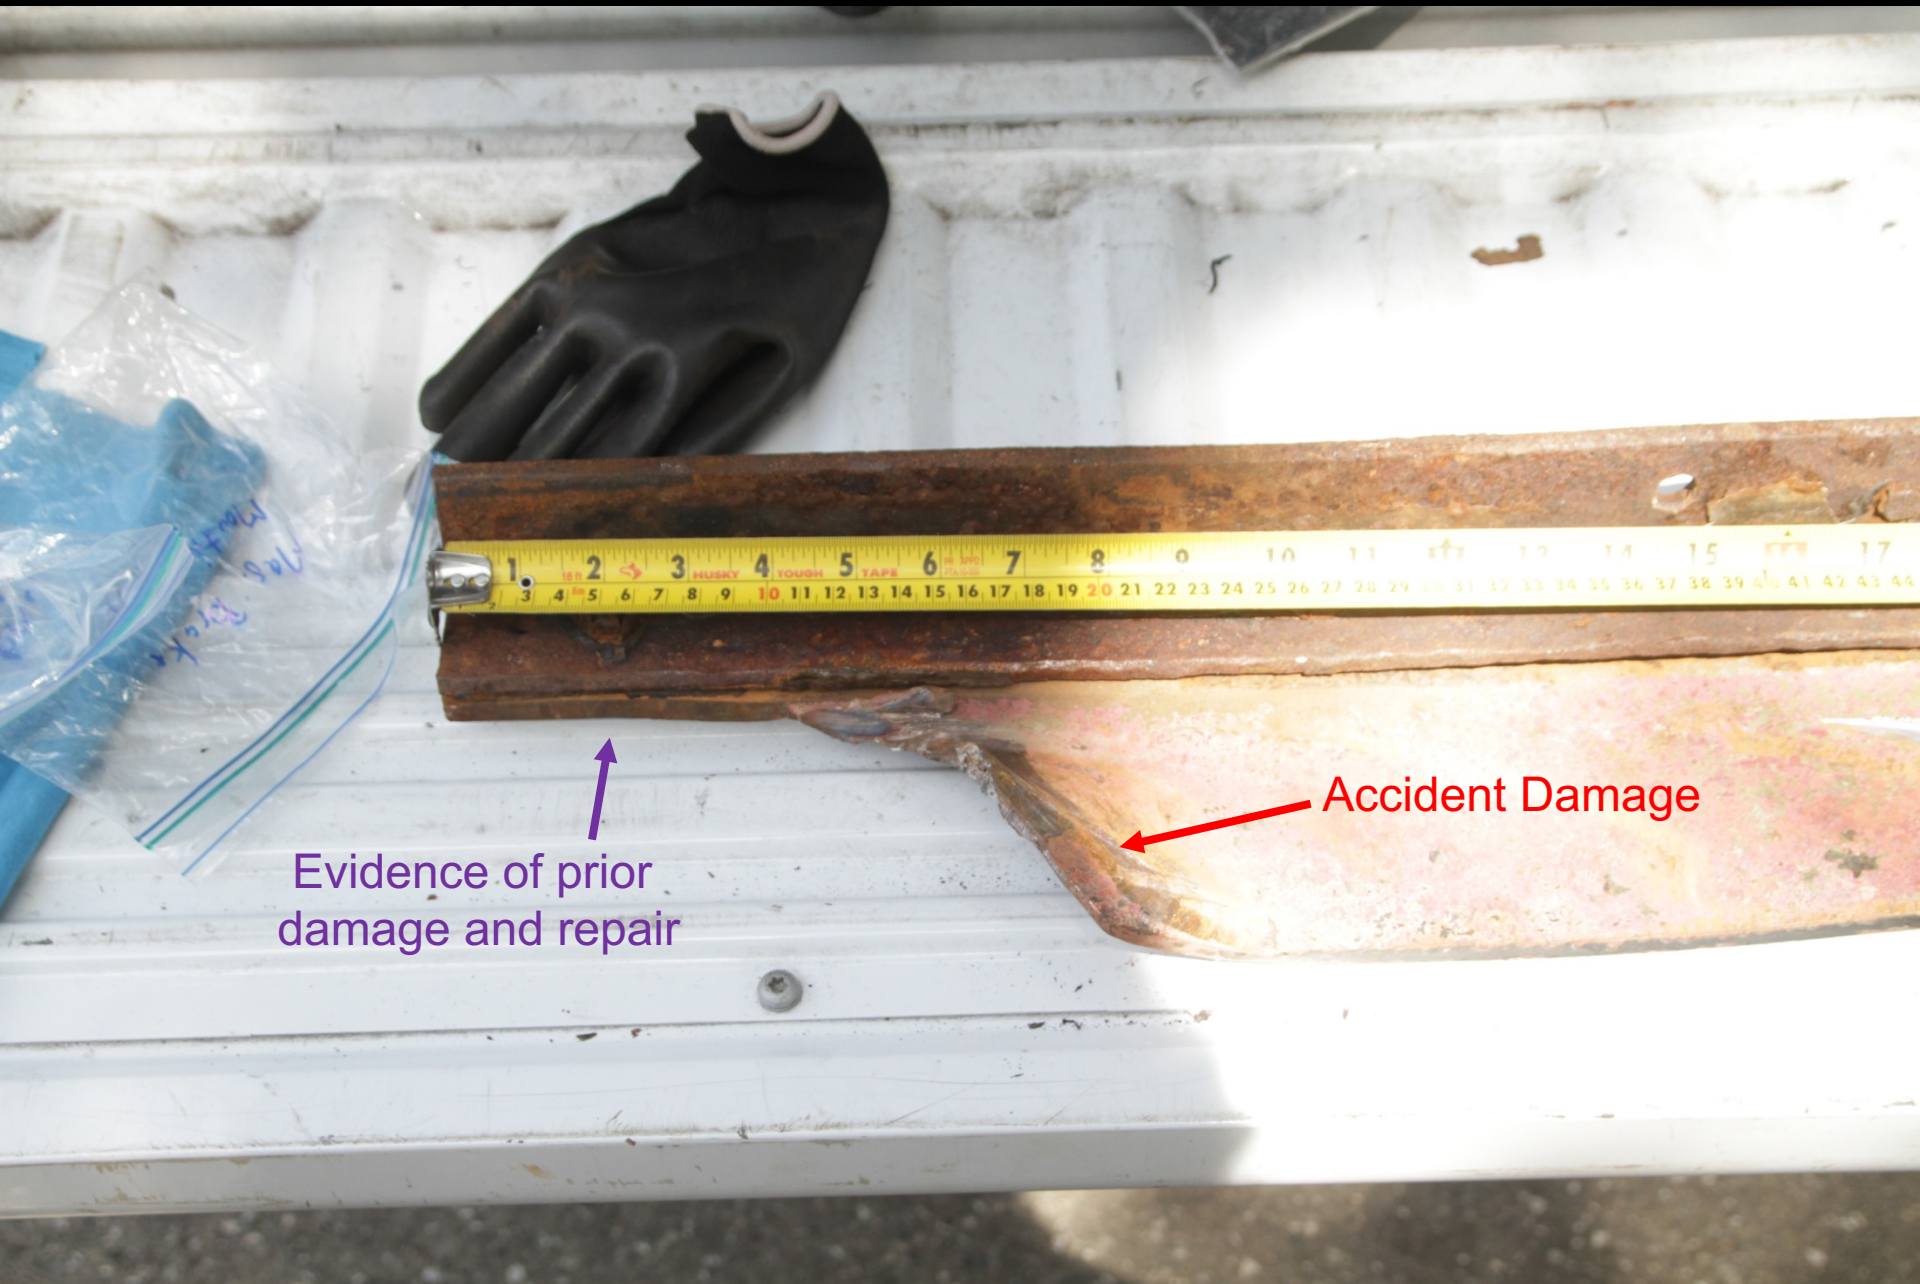
Further, the accident brake fin showed evidence of significant prior damage requiring part of the fin to be removed. Photos 13 and 14 shows the leading edge of the accident brake fin is missing and bent. Photo 15 shows saw marks which demonstrate part of the fin had been cut off in recent history. This cutting is again consistent with a prior event similar to the accident event.

Evidence of prior
damage and repair

Accident Damage

Lead Car's Damaged Brake Fin

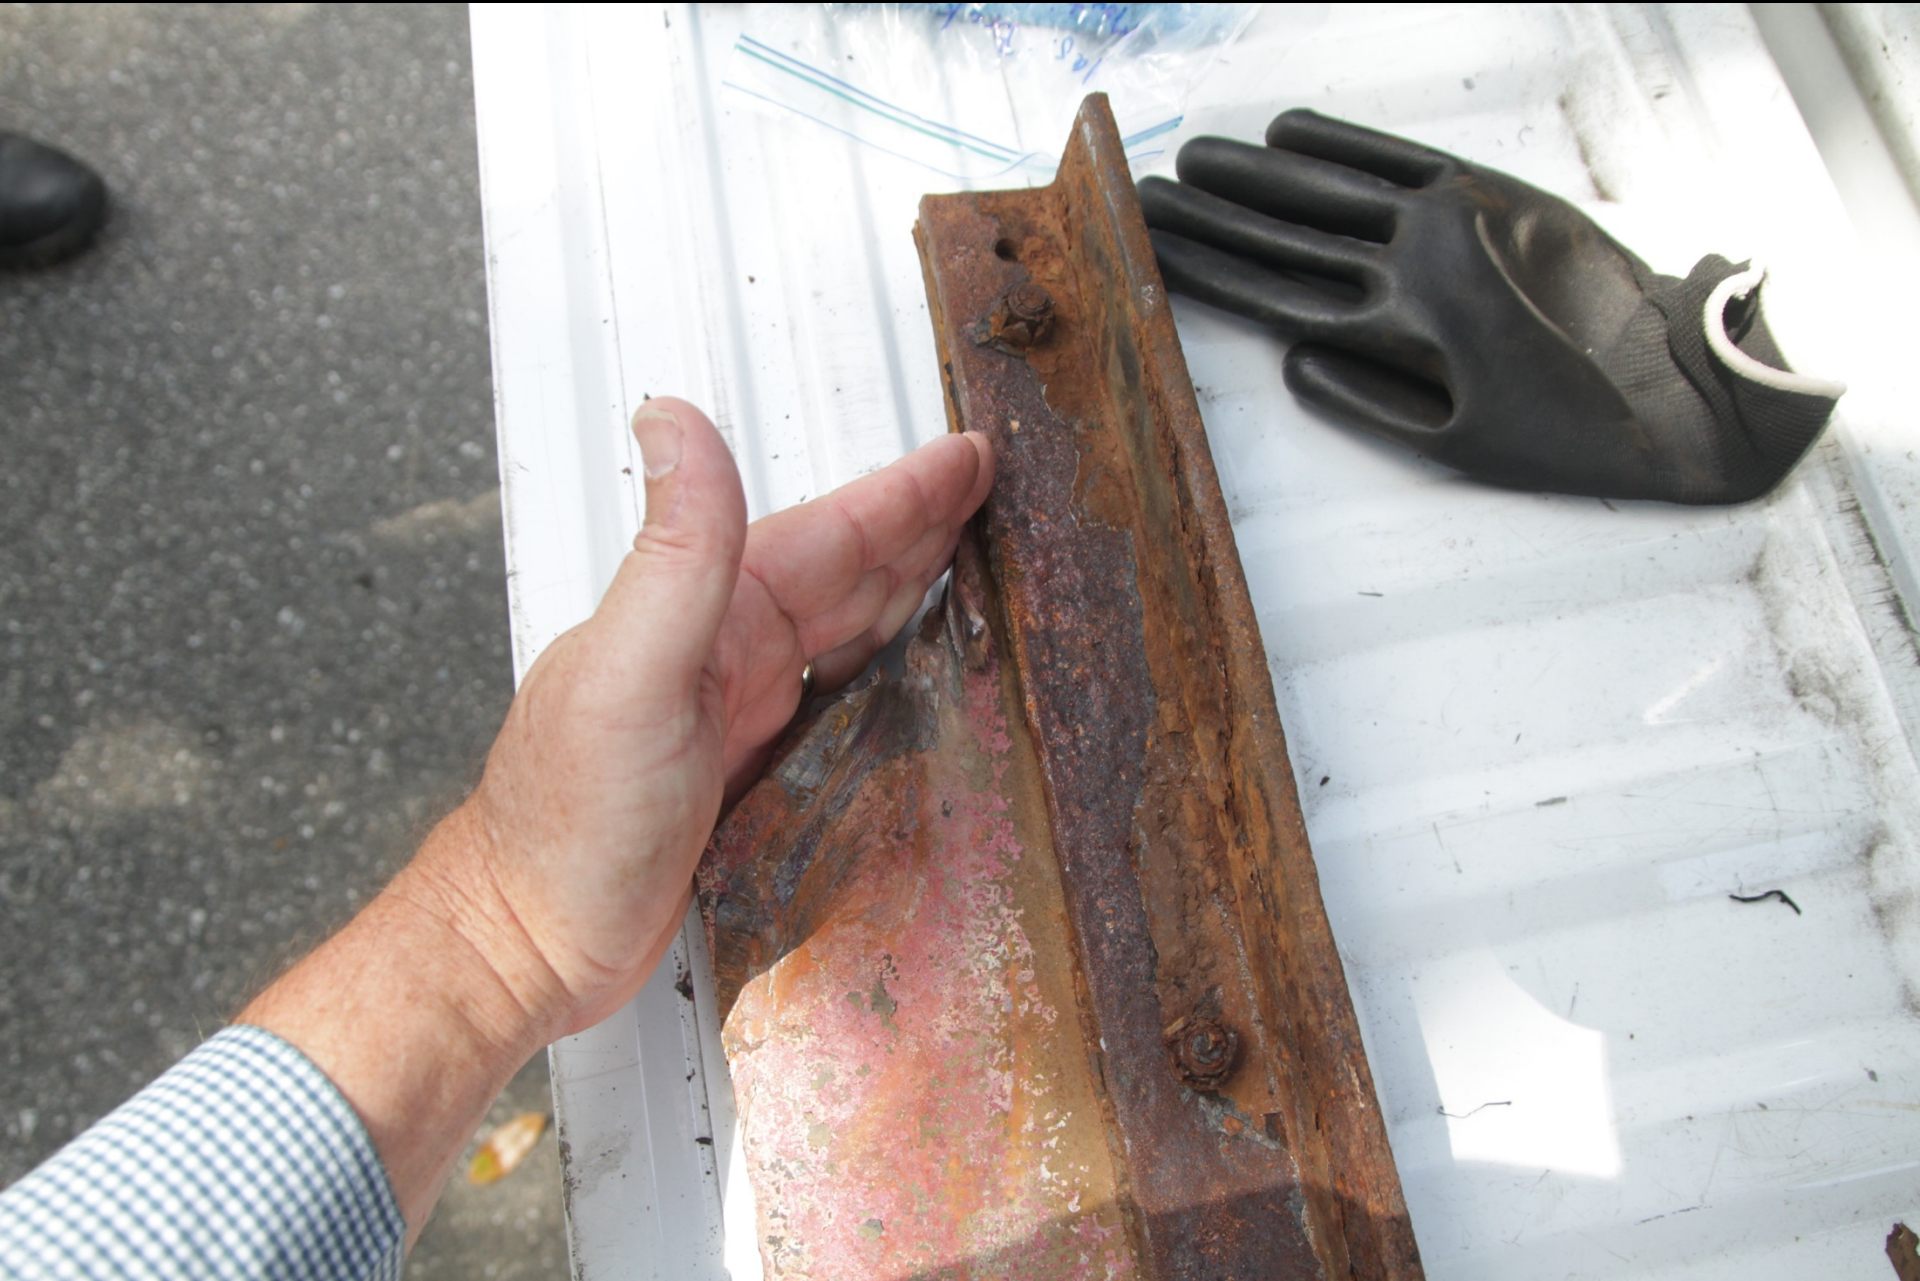
Brake Fin Repair Evidence

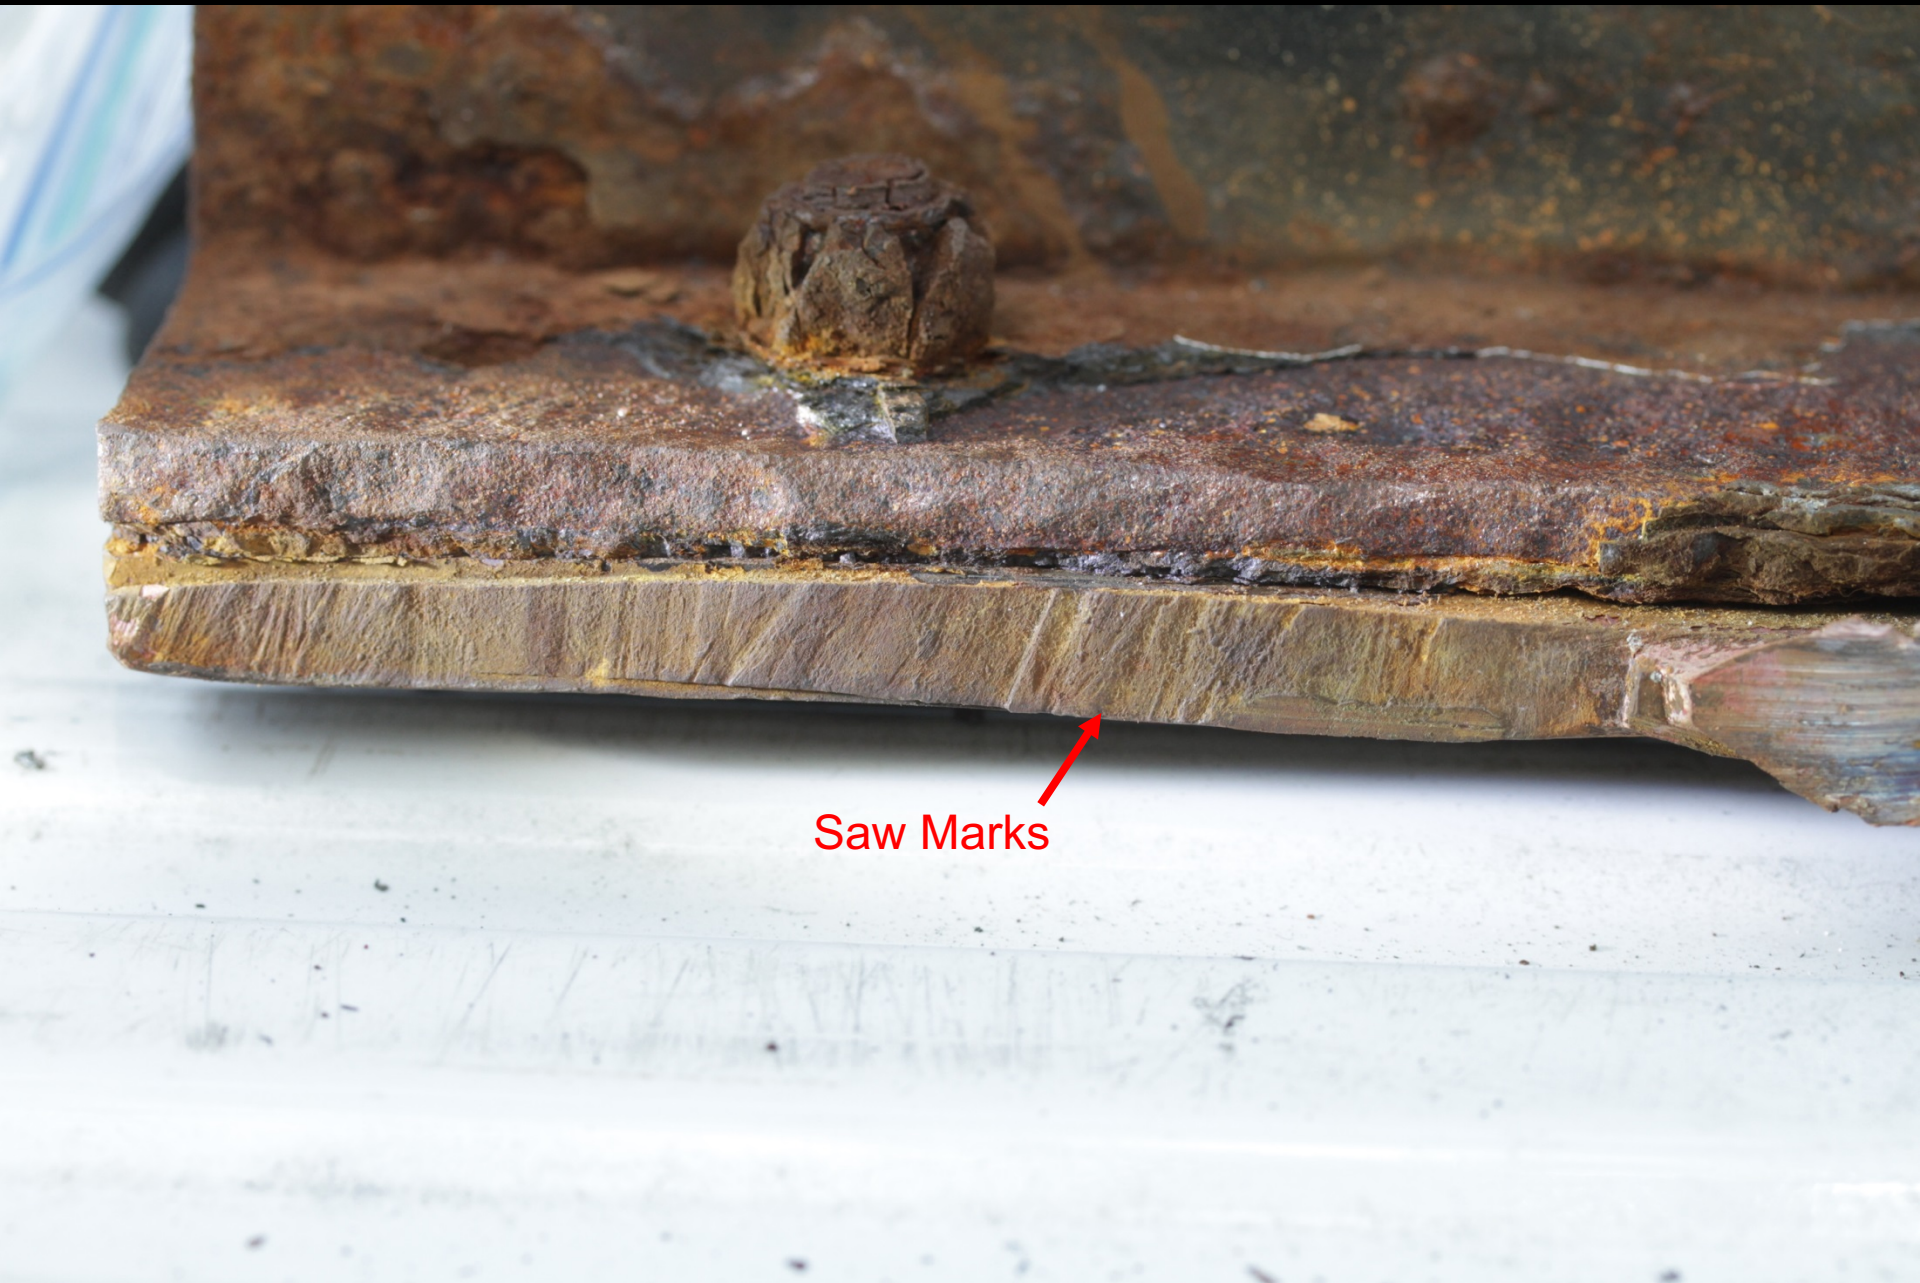
Saw Marks

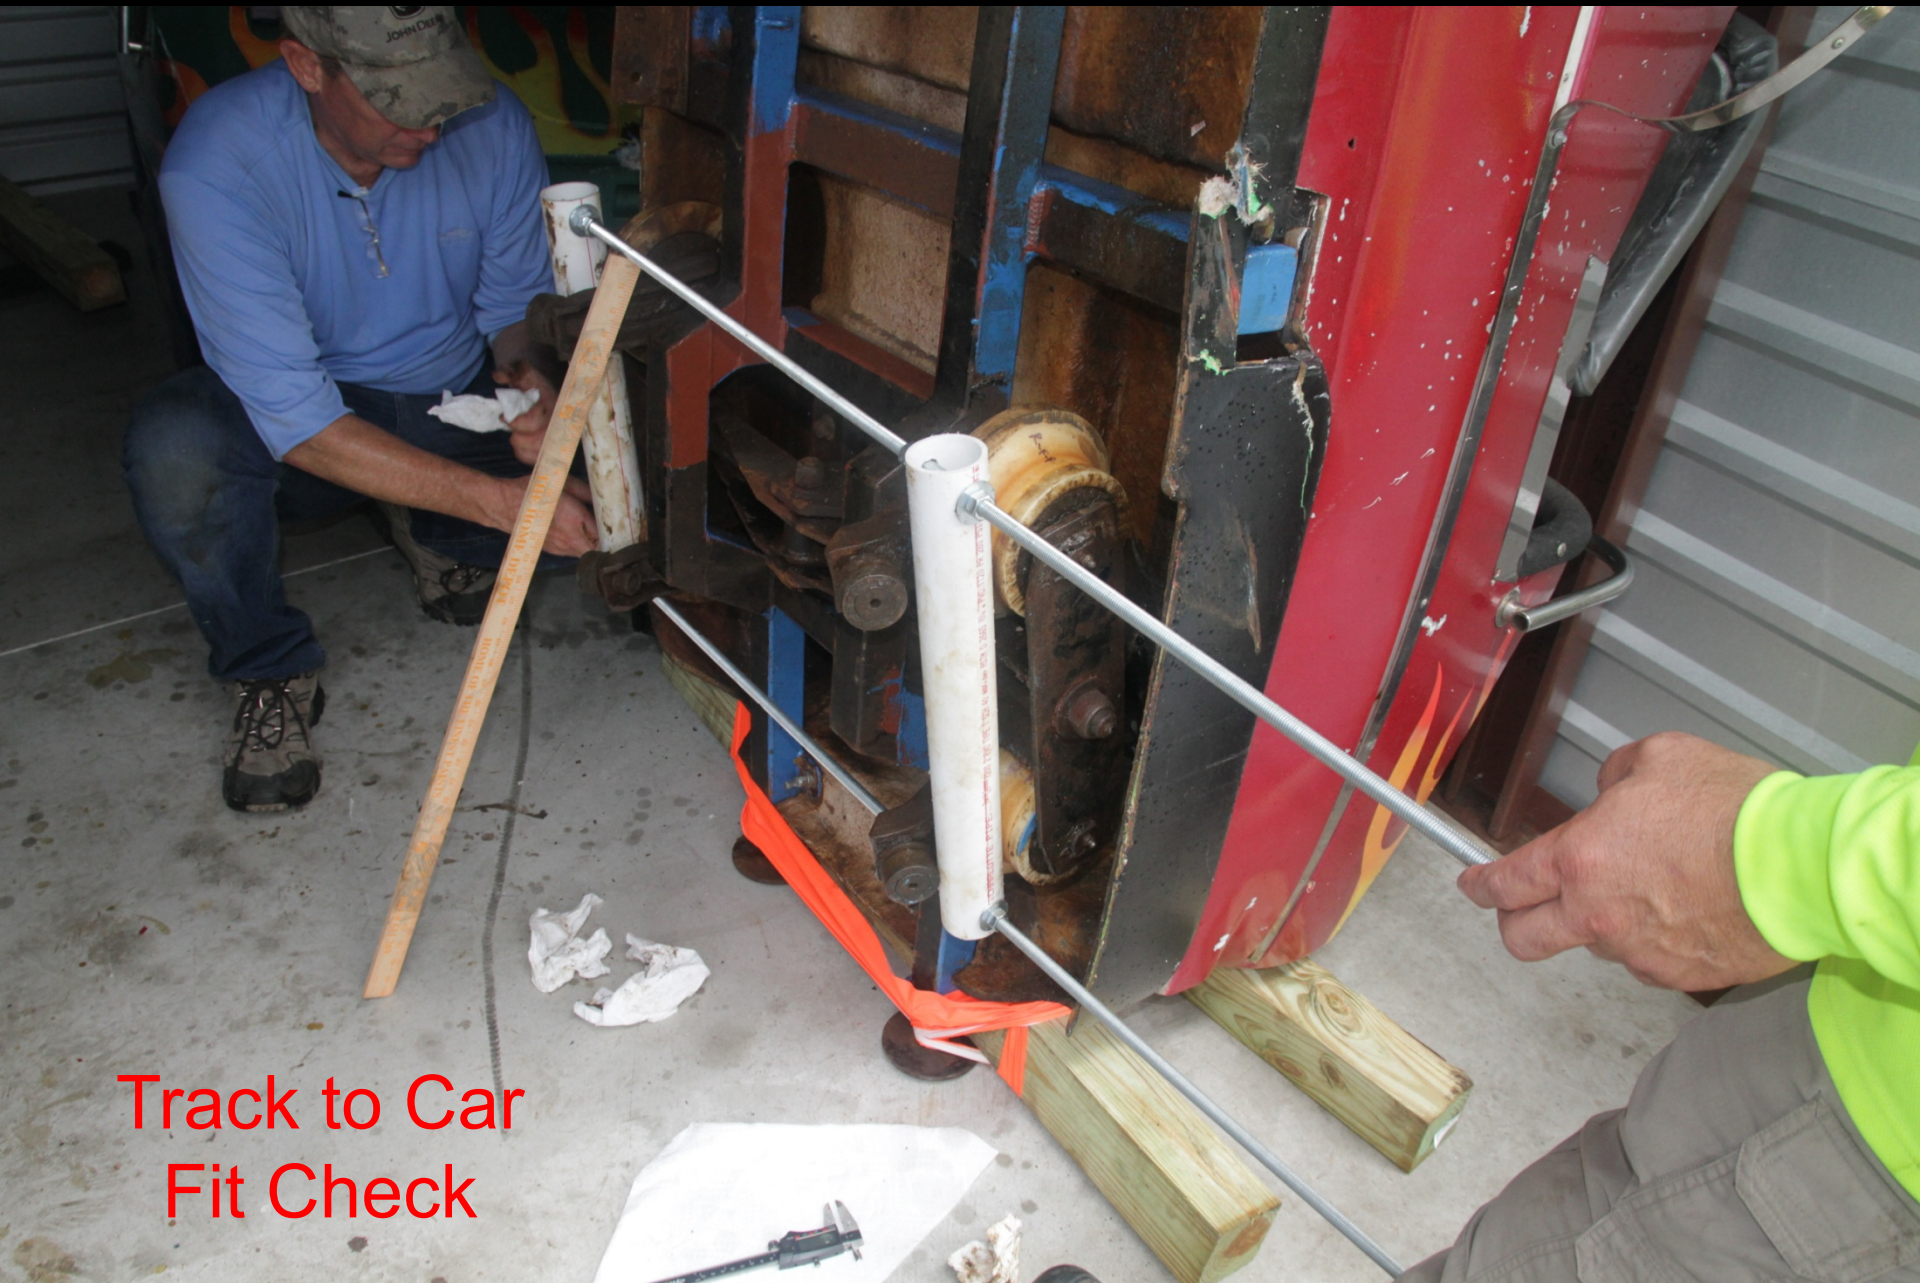
Car derailments also appear to have been a long term issue with this ride. For a car to derail, the safety wheel mechanism must be defeated which not only requires car over speed but also requires wear and strain in the axle assembly. During our investigation a track fit-up jig was made and fit onto the accident lead car. See Photo 16. Visual examination and measurements during this process did not reveal an obvious deficiency nor suggest that a derailment was reasonably possible. Simply put, the jig was well captured by the primary and safety wheels. This observation indicates that no single factor in the axle assembly caused the failure but rather the failure was likely the result of the initial design in combination with wear and strain "stacking". Stacking simply indicates that it is not the deficiency of one component but rather small effects of multiple components to produce a larger combined effect.

Track to Car
Fit Check

Lead Car

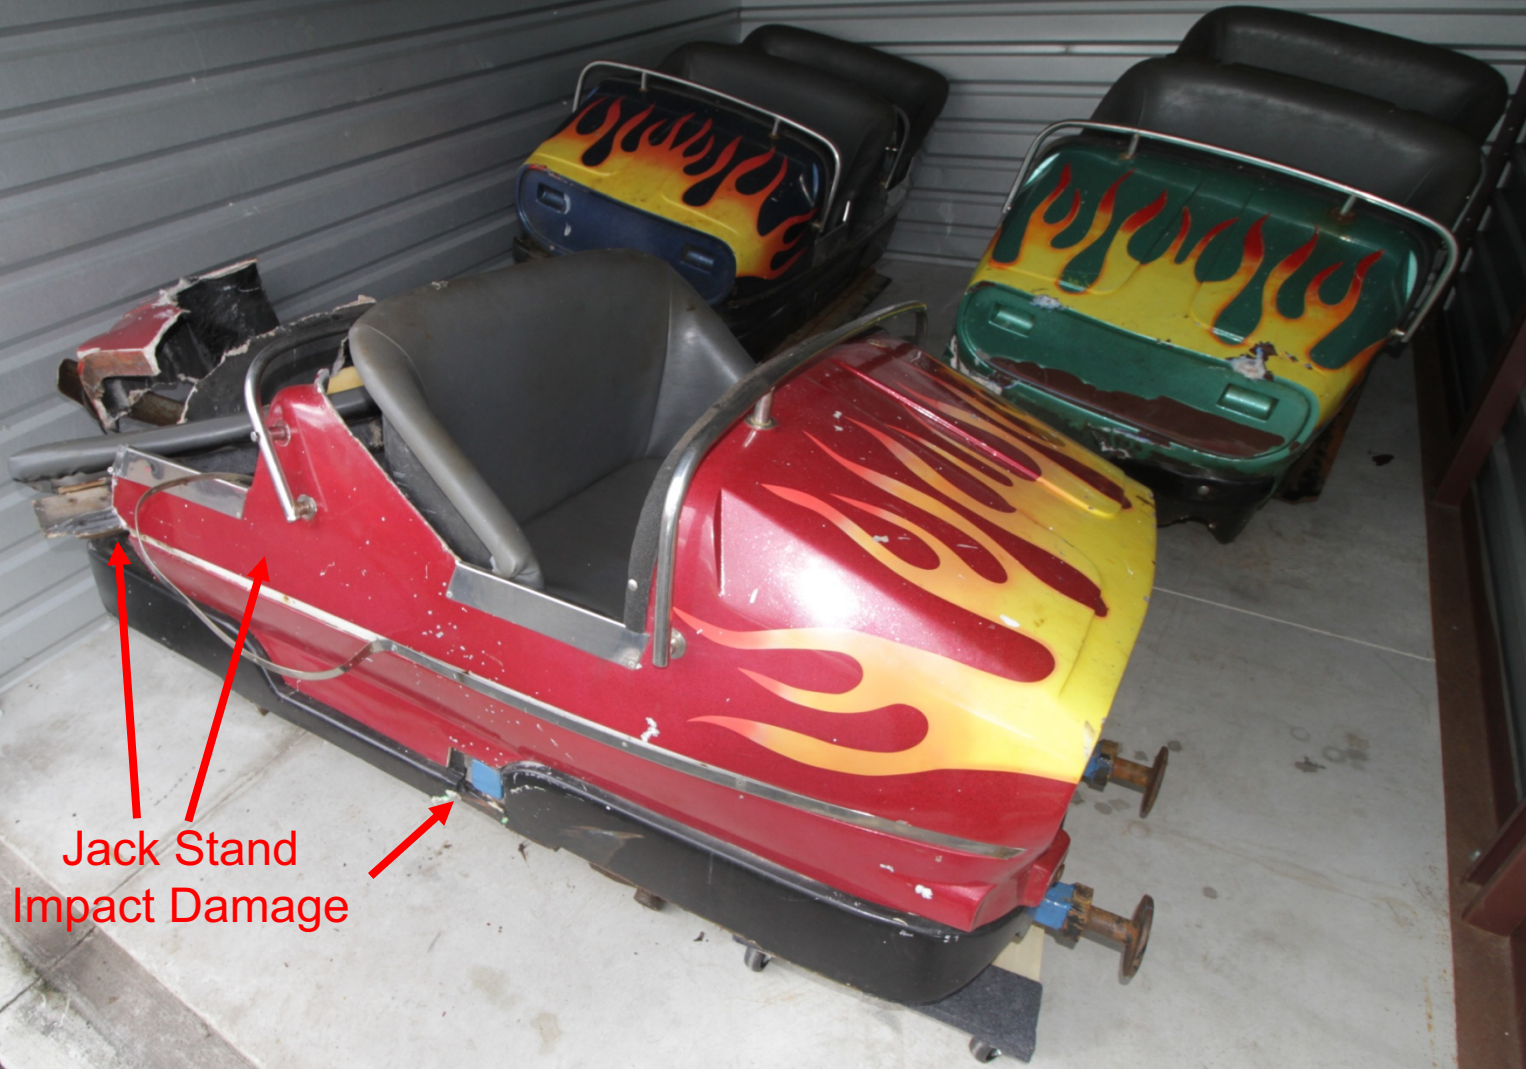
Inspection of the lead car revealed that the brake fin had been torn off at impact with the magnets. The car had grazed the vertical track support structure (jack stand) with its right side while exiting the track. The right side and handle of the second car wedged against the same jack stand arresting the forward motion of the cars. In total the lead car traveled about 35 feet total from accident initiation to rest. The accident was not a single impact event. The cars were traveling near 22 mph and speed loss occurred throughout the event during derailment, during the slide into the brake, during brake impact and bolt fractures, during jack stand side swipe and during second car derailment. When the car finally exited the track it was likely nearly stopped.

Jack Stand
Impact Damage

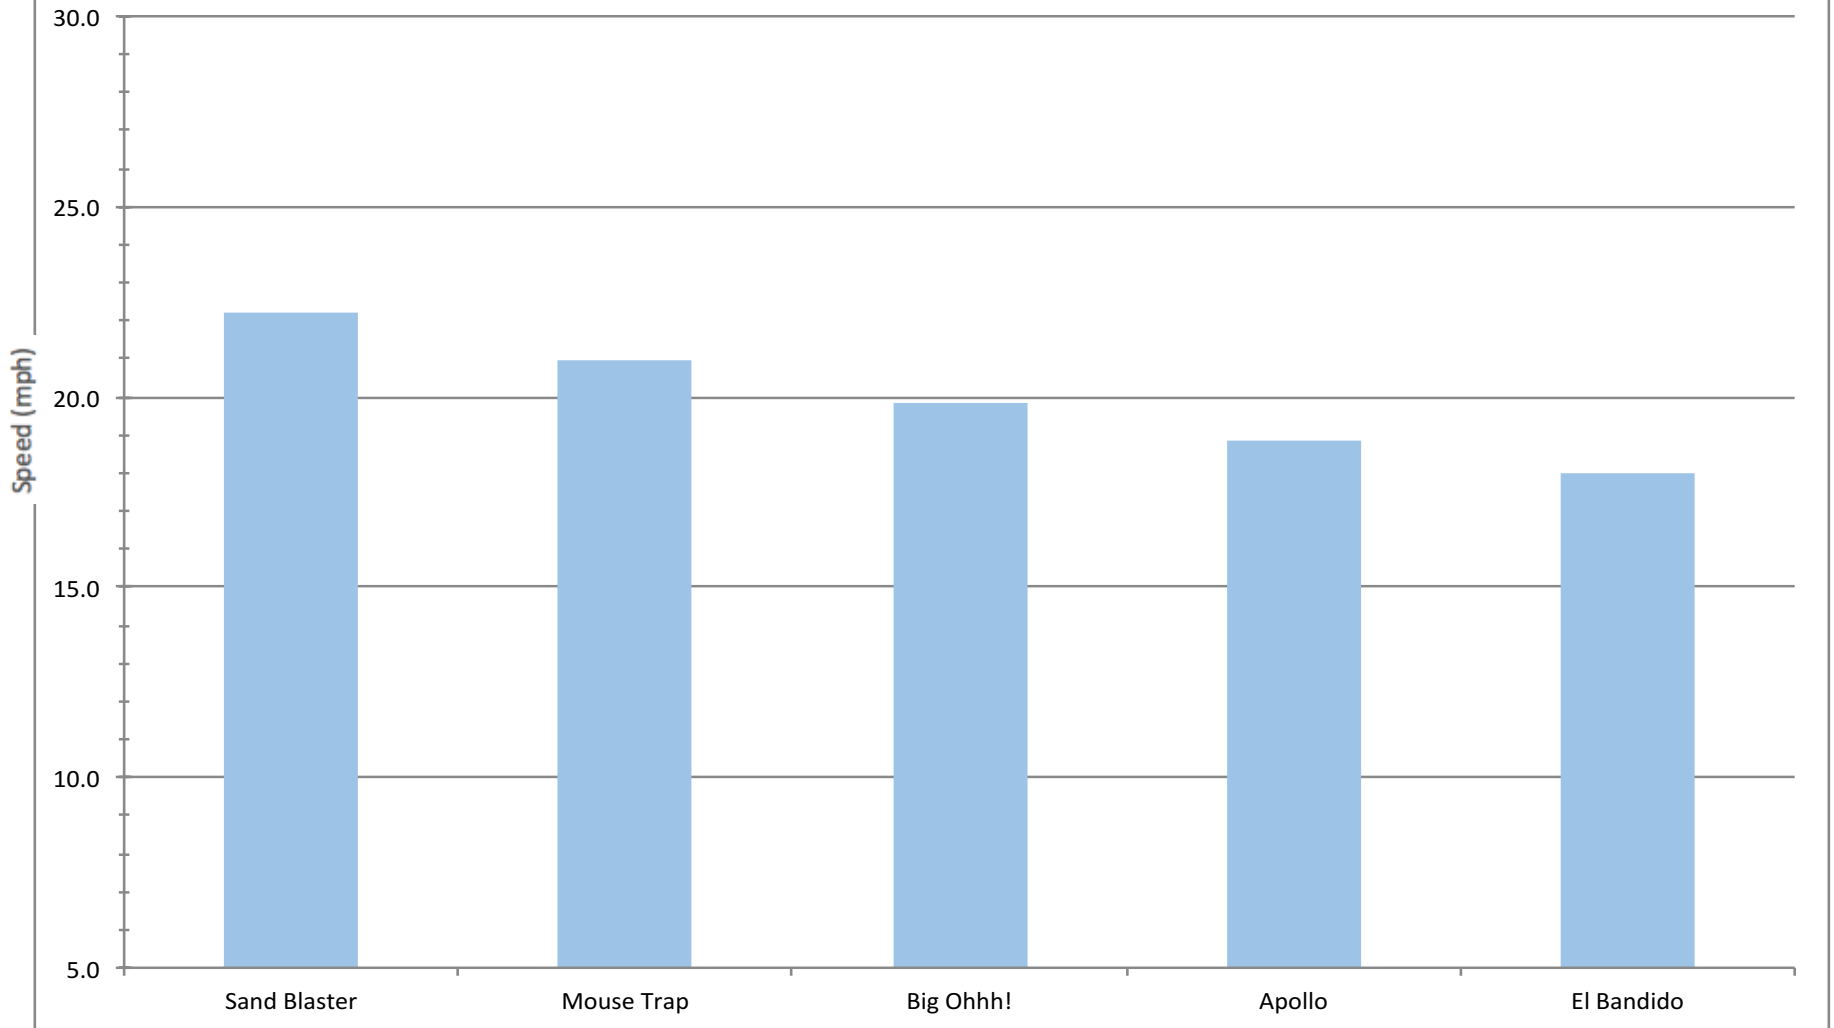
Figure 2

We also calculated speed of each ride in the accident area and at the end of the ride's last turn just before entering the boarding area. The Sand Blaster was unique from other 64M rides in that it consistently demonstrated higher speeds, see Figure 2. Figure 3 shows the individual speed calculations for each video analyzed. Again the accident ride showed consistently higher speeds. It also demonstrated speed gain coming through the brakes following the accident location. Note that the highest speeds recorded for the accident Sand Blaster were recorded just after the refurbishment.

Pinfari 64m Model Coasters Comparison Of Video Based Speeds (Two Selected Locations Only)

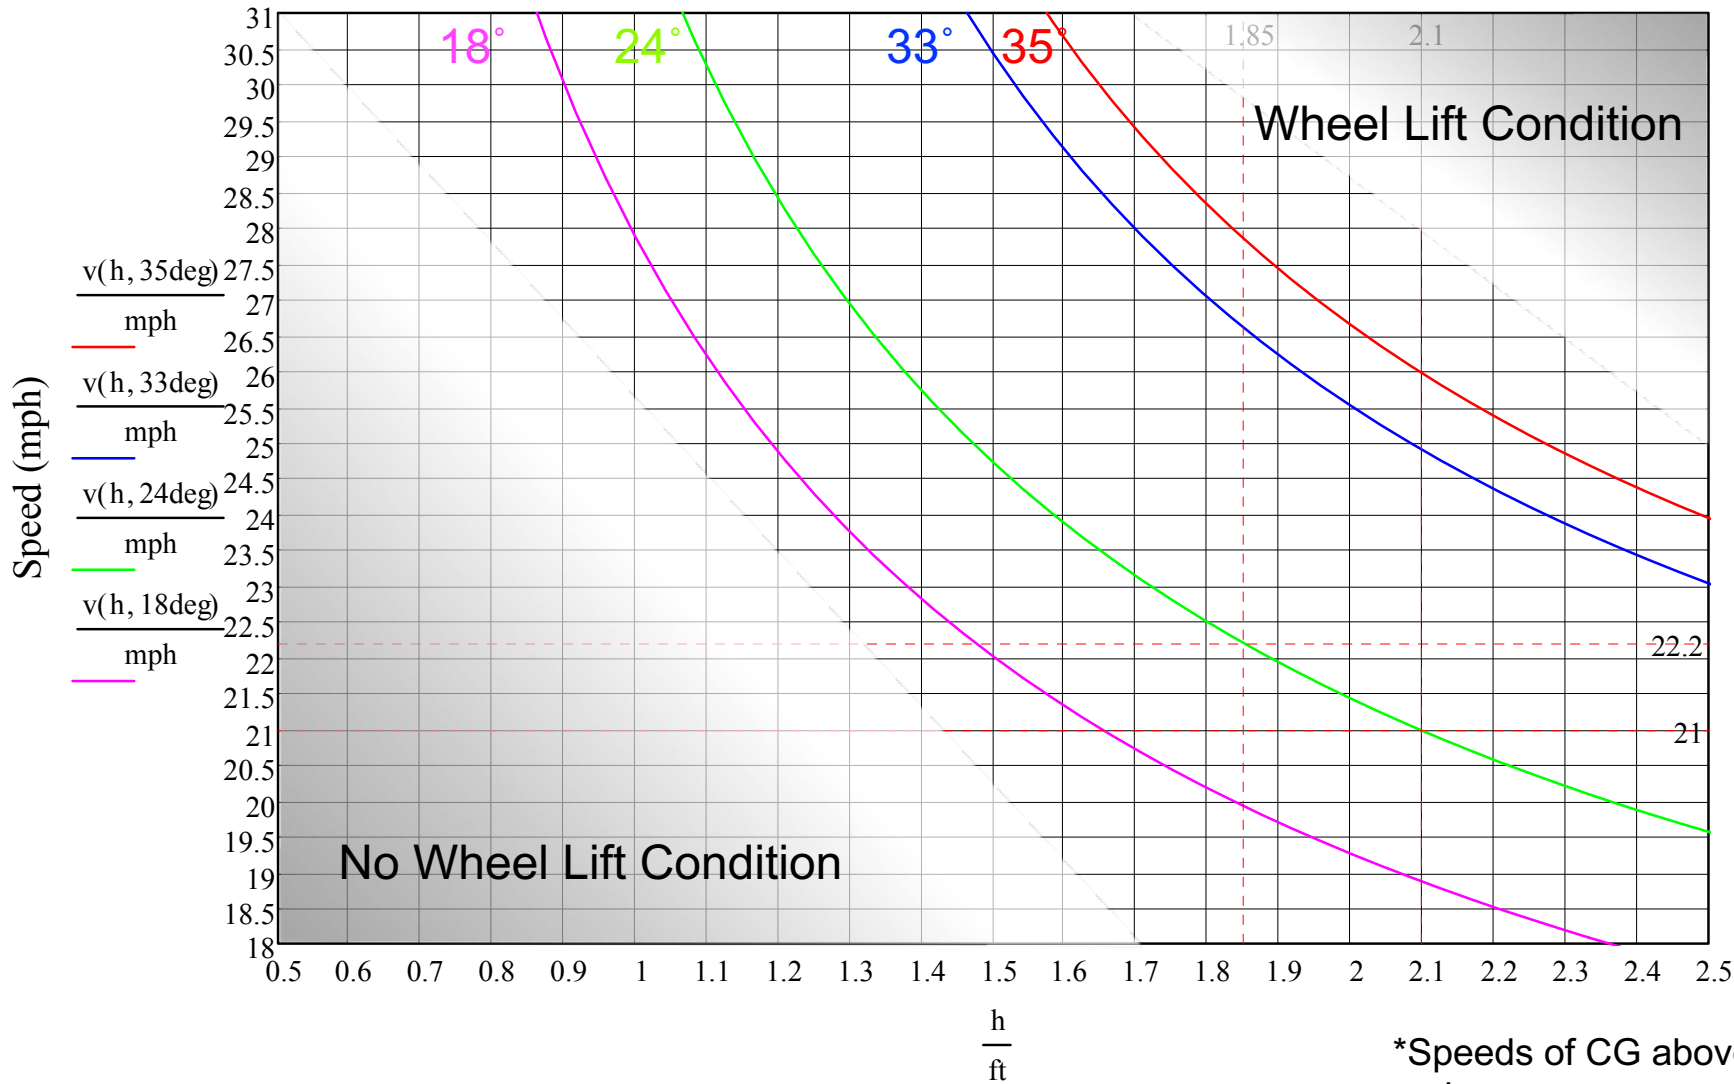
Figure 4

We also calculated the effect of speed versus center-of-gravity (CG) height in Figure 4. Fundamentally, the rides that operate above 20 mph are highly subject to safety wheel contact. Additionally, ride loading is likely a contributing factor. Note that manufacturer's literature that we have reviewed does not indicate an appropriate operational speed at any point. It appears because it is a gravity ride, speeds are designed into the ride through controlling the change of elevation.

Lift Velocities Vs CG Height For Various Bank Angles in a 23ft Radius Curve

*Speeds of CG above a given curve represent a wheel lift condition

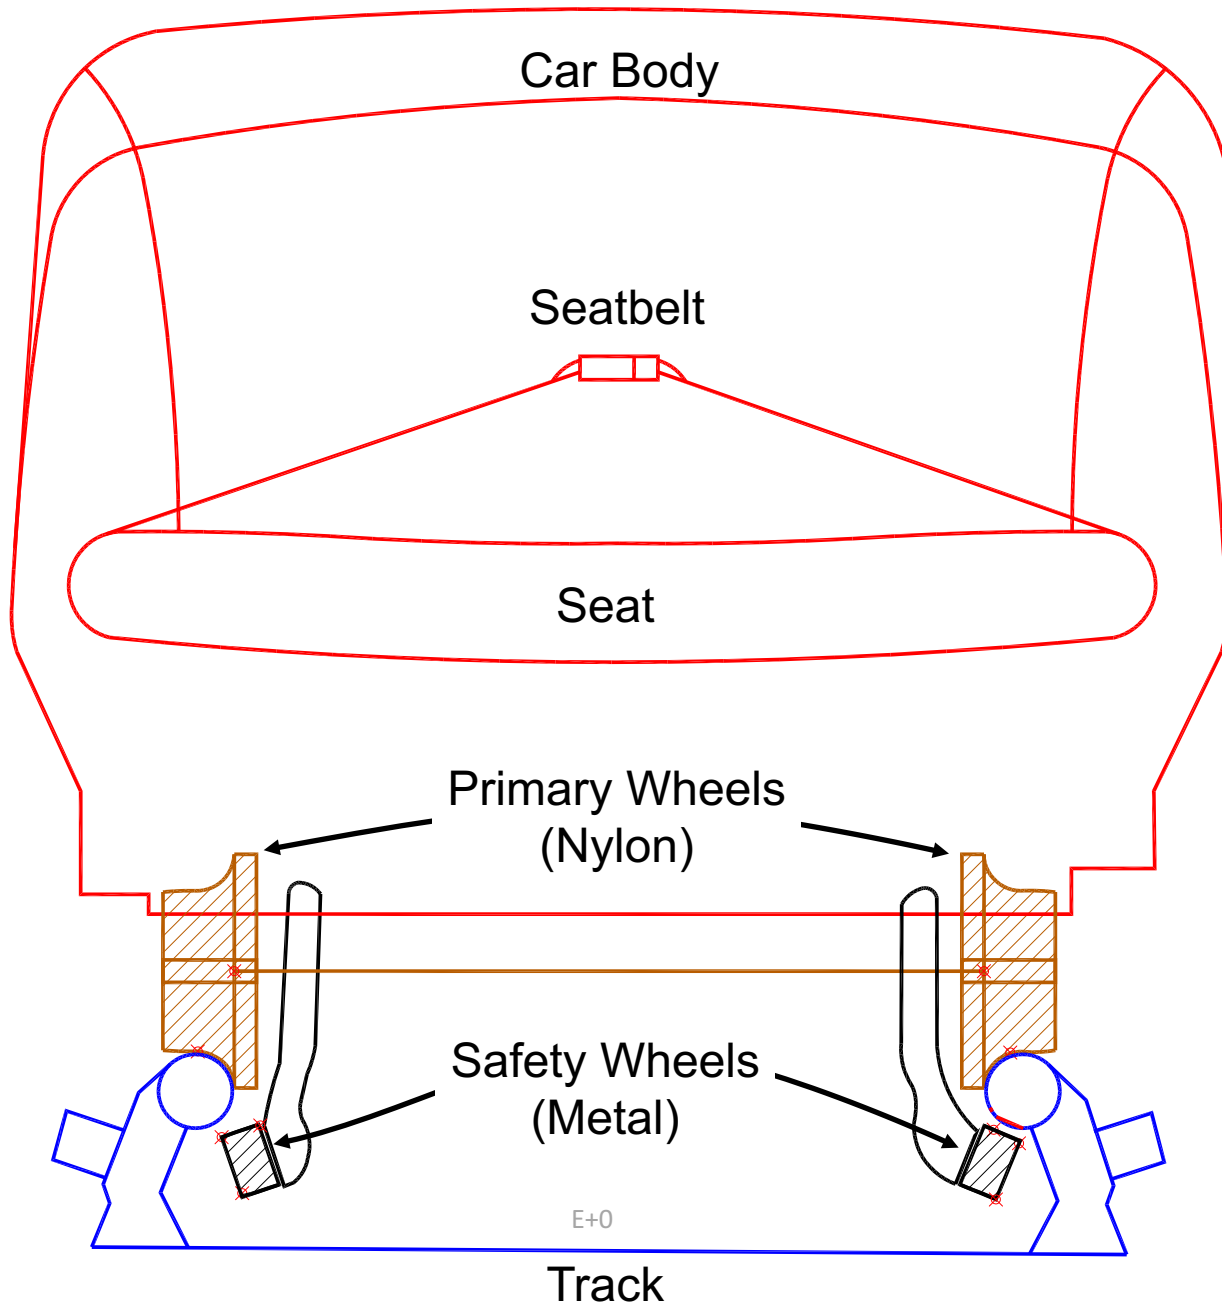
Track and Axle Detail Dwg 3

The Subject rollercoaster is a simple car on wheels design that follows a metal track similar to a locomotive on a train track. The ride is a gravity ride, meaning that the cars are rolling from a location of higher elevation to a lower elevation to generate speed. Simply put, the cars are rolling downhill on specifically shaped wheels to follow along a metal track made of two inch diameter steel pipe. The ride is not intended to perform negative G's, inverted activities or extreme maneuvers. In the event that a car does attempt to lift off the track, the car has "safety wheels" that extend underneath the track to prevent the car from derailing. Photos 4 and 5 show a derailed car and a properly tracked car. The metal safety wheel is visible beneath the track on the left most car and the tan colored nylon primary wheel is visible in the derailed condition on the right most car. See Drawing 3.
