June 14, 2018 Accident
Failure Investigation Report
Sand Blaster Roller Coaster
Boardwalk Amusements, Daytona Beach, Florida

Prepared for the Florida Department of Agriculture and Consumer
Services, Bureau of Fair Ride Inspections

Failure Analysis Investigation Report
June 14, 2018 Accident
Sand Blaster Roller Coaster
Boardwalk Amusements Daytona Beach, Florida
Florida Department of Agriculture and Consumer Services, Bureau of Fair Ride Inspections

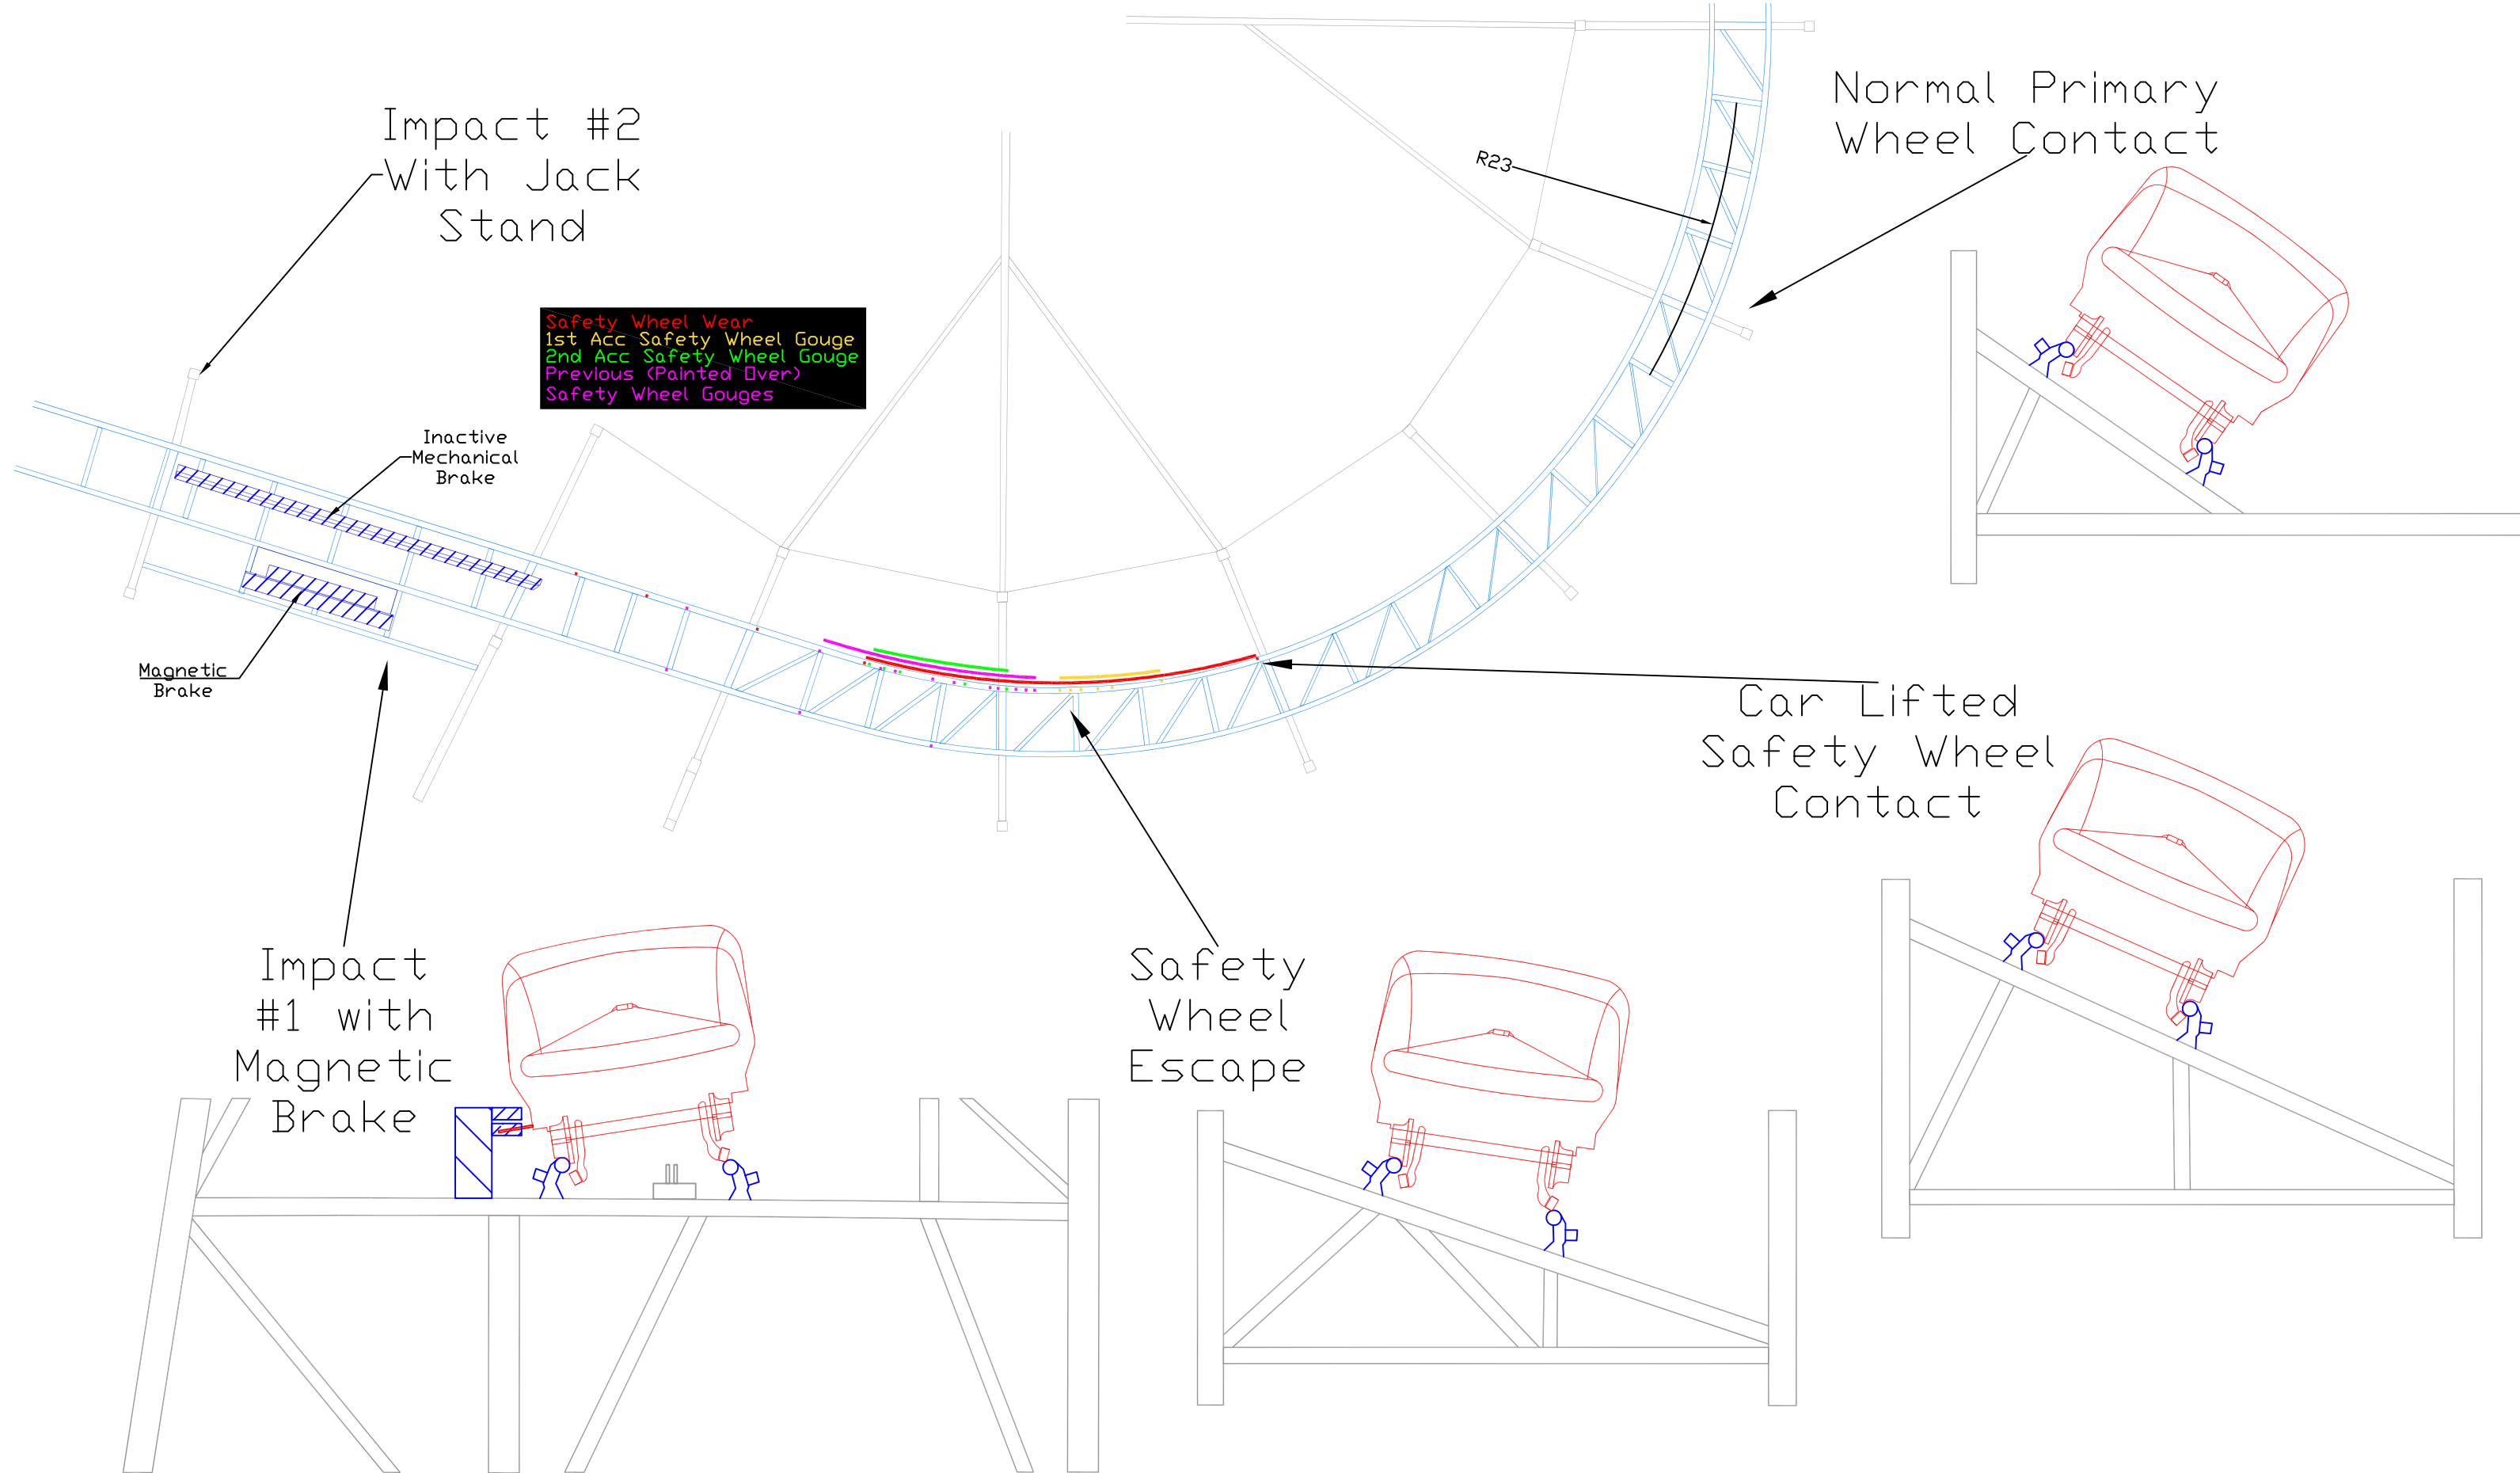
Accident Sequence Dwg 4

At the time of the accident, the lead car became partially derailed due to over speed and then slid along the tracks until a portion of the car impacted a fixed brake structure leading to a full derailment. The car did not fall to the ground because it was still connected to the second car which had derailed but was still located on the track. The third car did not derail. A more detailed accident sequence is attached entitled "Accident Sequence". See Drawing 4, the Accident Sequence Drawing.

Subsequent to the partial derailment, the car then slid along the track in this partially derailed condition until reaching the location where an aftermarket magnetic brake system had been retrofitted onto the track. At this location, the car's aftermarket brake fin (which was now misaligned to the tracks magnetic brake channel) struck the track's brake magnet, damaging both and pushing the car off the track to the right. Because the car's right side was elevated, the brake on the left side was misaligned below its channel. See Drawing 4: Impact #1 detail.

- The left side of the car, now being lower due to the tilt, hit a magnetic brake structure with the car's brake fin which severed the brake fin structure from the car and pushed the car off to the right. (Drawing 4)
