June 14, 2018 Accident
Failure Investigation Report
Sand Blaster Roller Coaster
Boardwalk Amusements, Daytona Beach, Florida

Prepared for the Florida Department of Agriculture and Consumer
Services, Bureau of Fair Ride Inspections

Failure Analysis Investigation Report
June 14, 2018 Accident
Sand Blaster Roller Coaster
Boardwalk Amusements Daytona Beach, Florida
Florida Department of Agriculture and Consumer Services, Bureau of Fair Ride Inspections

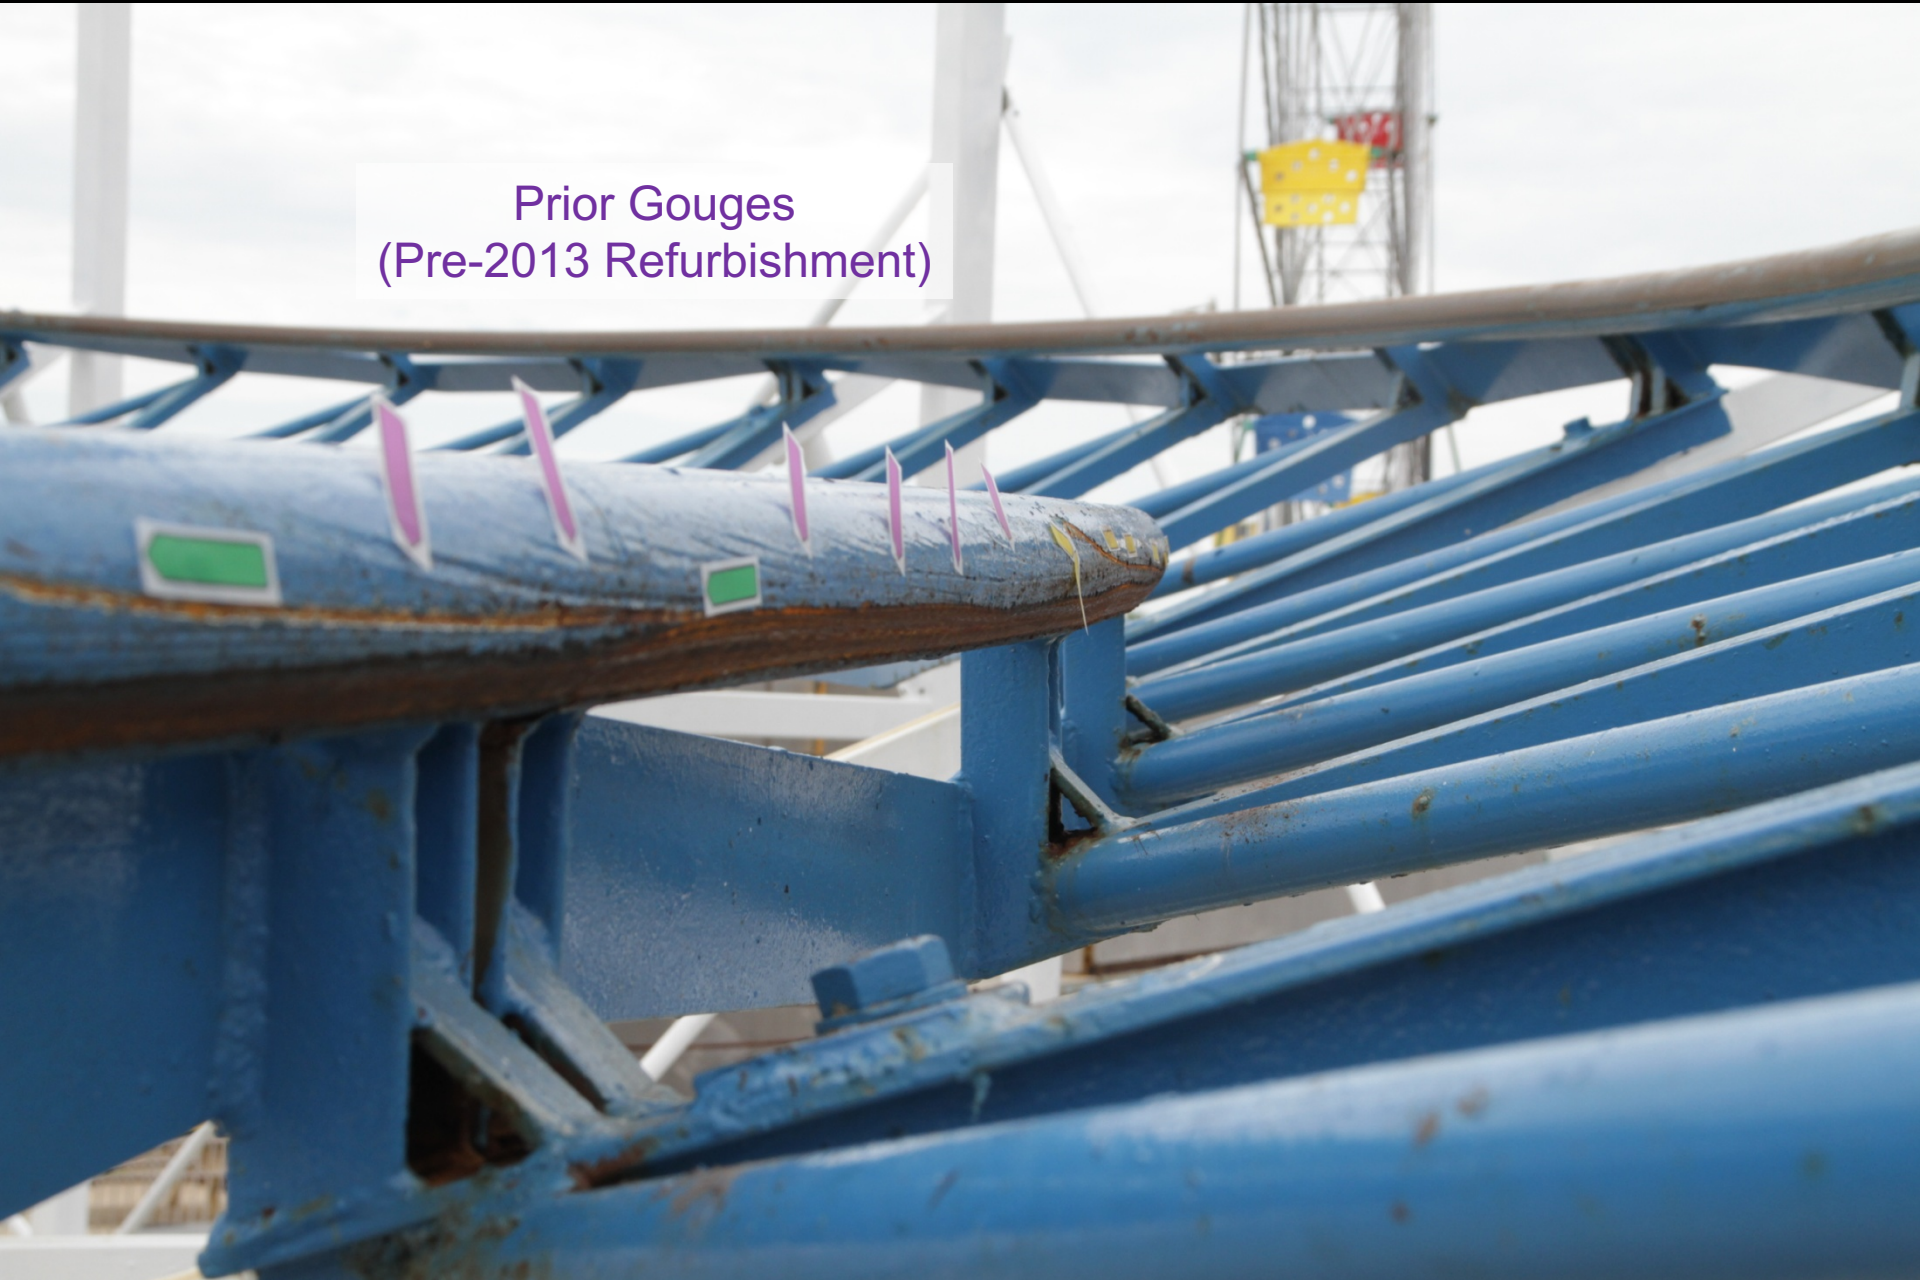
Current Accident Gouge
(Note: Chipped paint
and fresh rust.)

Worn Track

Prior Gouges
(Pre-2013 Refurbishment)

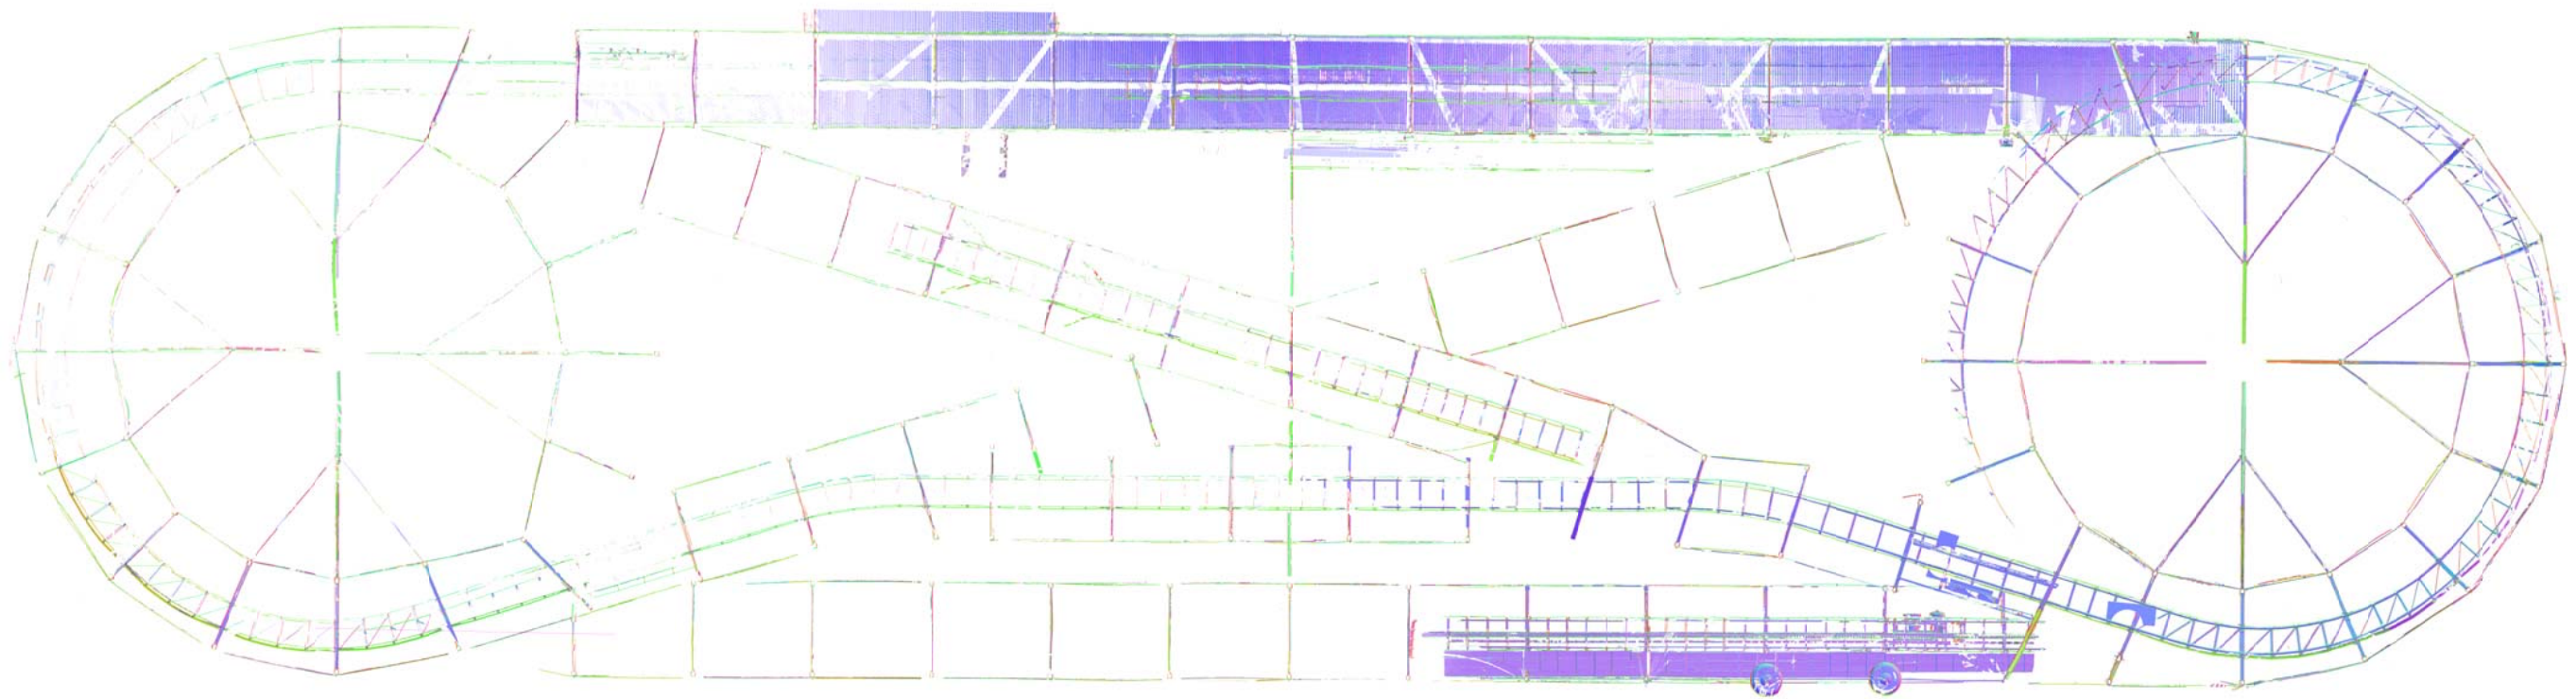
Figure 4

We also calculated the effect of speed versus center-of-gravity (CG) height in Figure 4. Fundamentally, the rides that operate above 20 mph are highly subject to safety wheel contact. Additionally, ride loading is likely a contributing factor. Note that manufacturer's literature that we have reviewed does not indicate an appropriate operational speed at any point. It appears because it is a gravity ride, speeds are designed into the ride through controlling the change of elevation.

*Speeds of CG above a given curve represent a wheel lift condition
